## Four-Point Inspection Form

Howard Meeks  
Meeks Property Inspections  
407-633-1661  
HI9966

Insured/Applicant Name: Howard Meeks Application / Policy #: \_\_\_\_\_  
Address Inspected: 123 Orlando Way  
Actual Year Built: 1988 Date Inspected: November 4, 2025

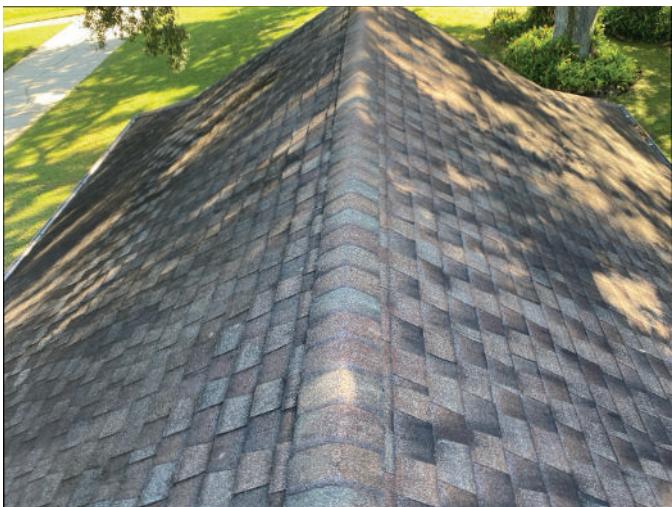
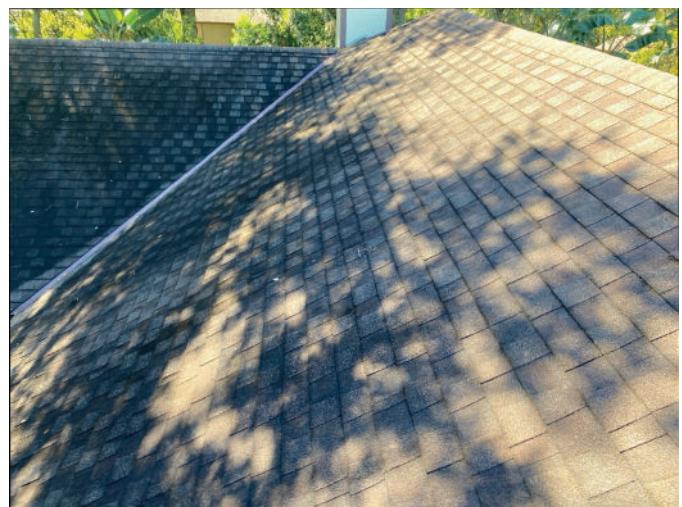
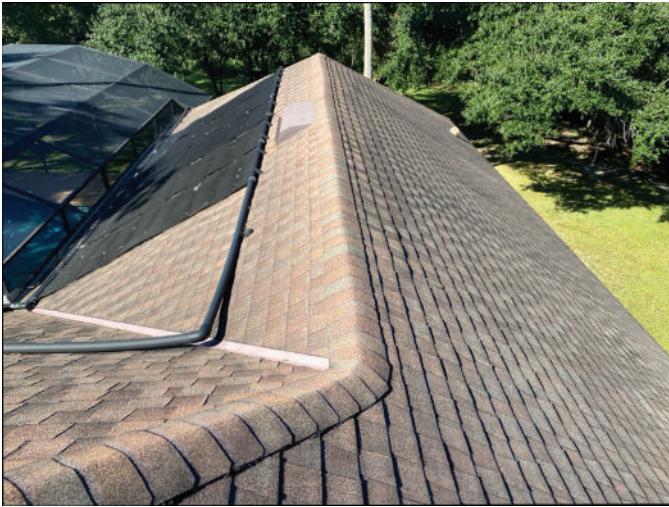
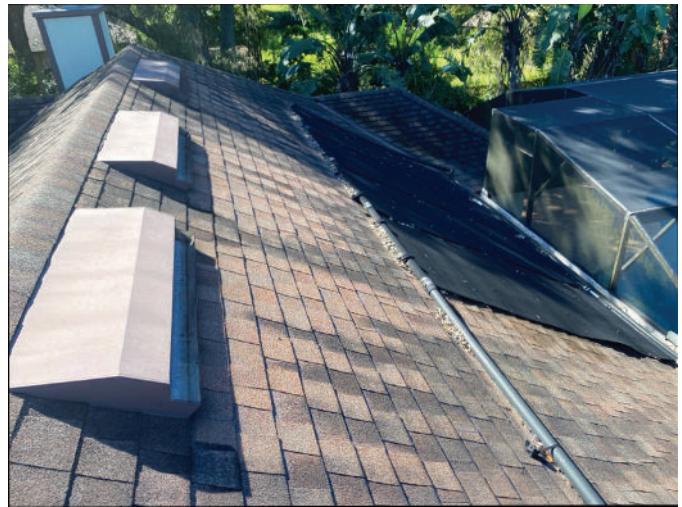
Roof

Architectural shingle roof installed in 2011. The roof is in good condition with normal granule loss for the age. No active leaks were detected.

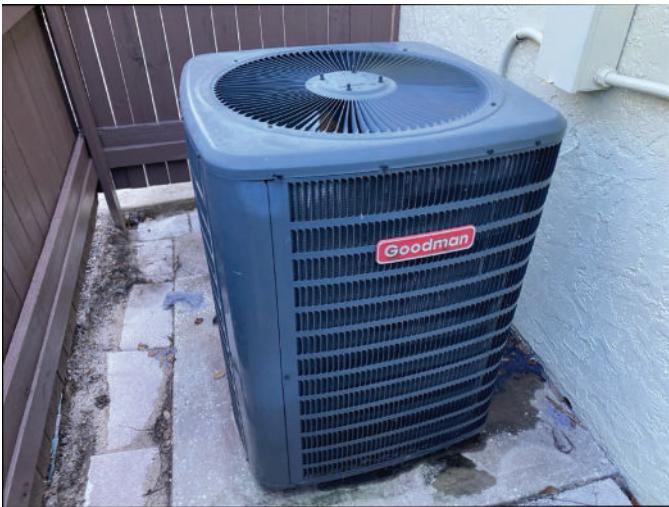
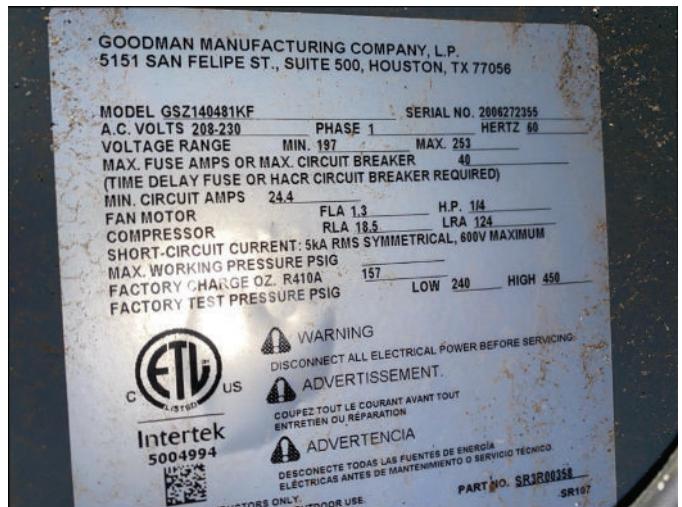
Air Conditioner

HVAC system manufactured in 2020. The system is in good working condition.

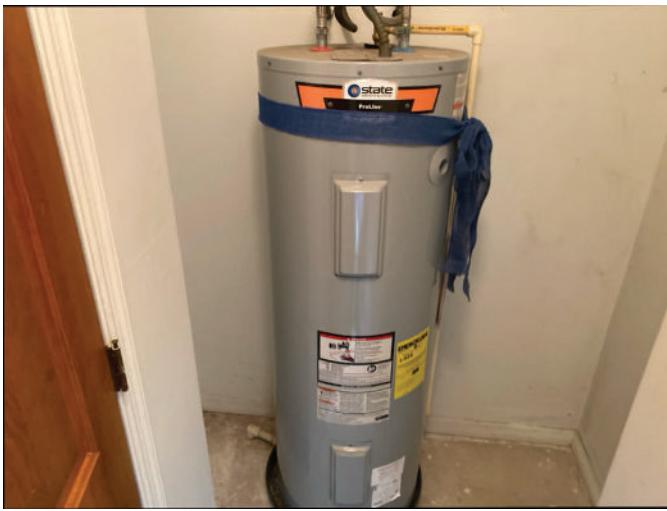
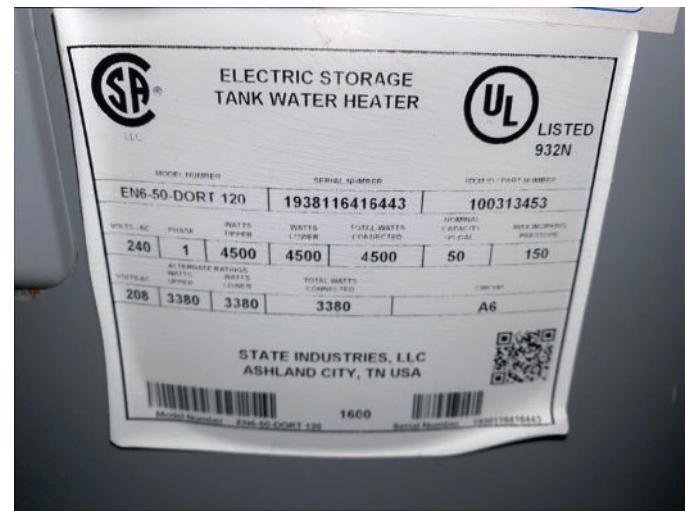
Water Heater

Water heater manufactured in 2019.

Is there any indication of an active leak?  Yes  No Is there any indication of a prior leak?  Yes  No The unit is in good working condition.

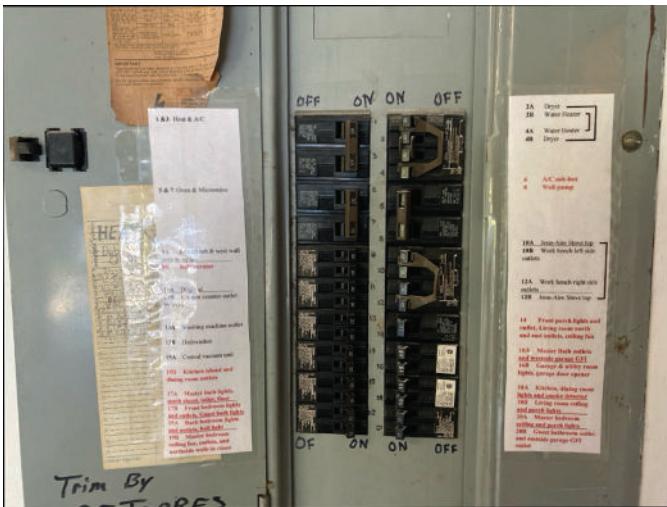
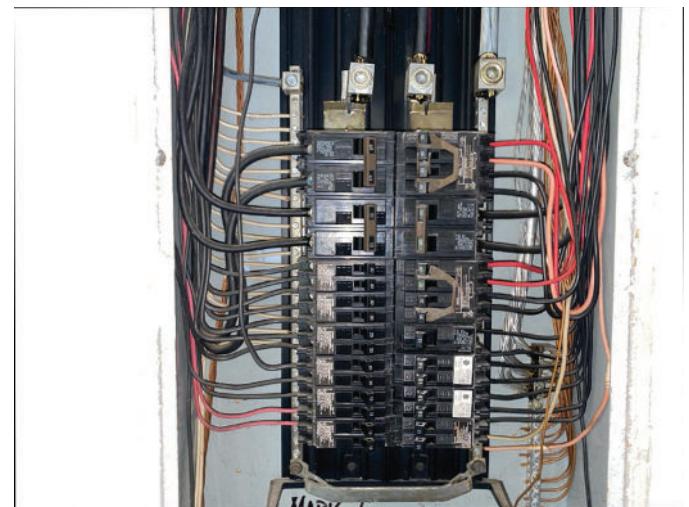
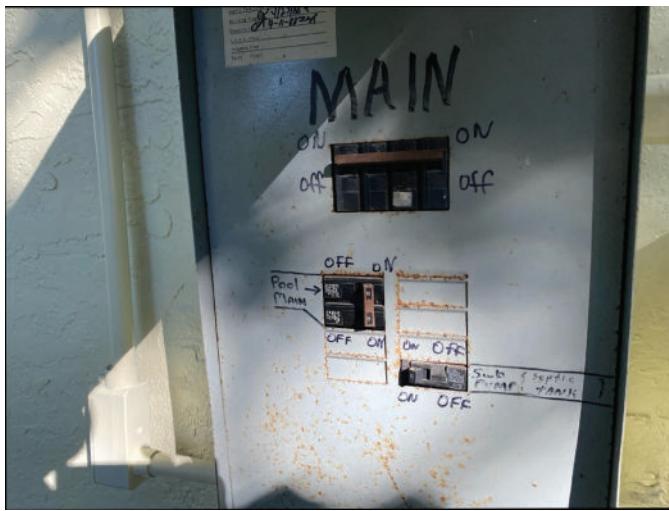
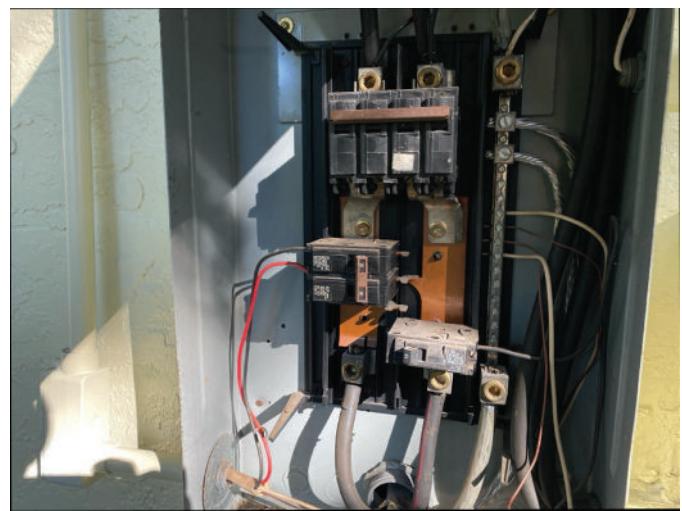
Electrical panel

Siemens service & sub panels installed. The electrical system is in good working condition.
