# PROPERTY INSPECTION REPORT

Date of Inspection: 11/25/2025 | Size: 1631 | Weather:

## MEEKS

907 Red Dandy Drive, Orlando, FL

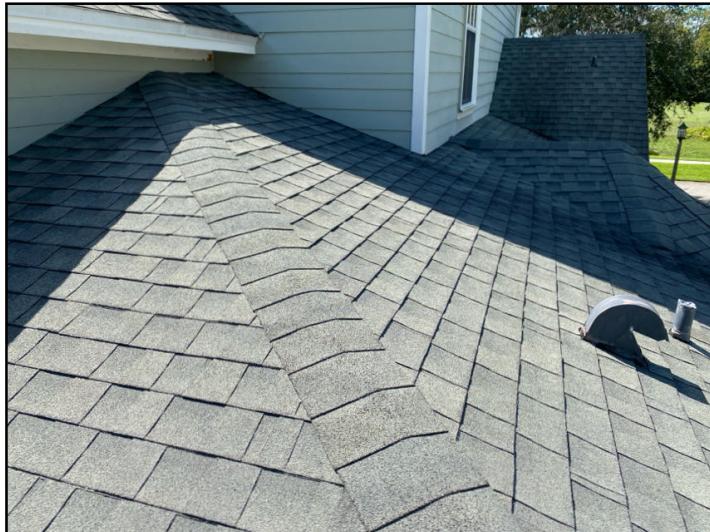
- The age of the roof system is nearing or past the 15 year mark. Due to this you may start running into issues with insurance once a shingle roof reaches 15 years of age. This can reduce the number of companies willing to write policies on the home. It's recommended to consult with your insurance agent to find out how this can affect you in the near future.
- Asphalt composition shingles covering the roof of this home exhibited moderate general deterioration commensurate with the age of the roof. They appeared to be adequately protecting the underlying home structure at the time of the inspection.

Architectural shingle roof installed in 2012. The roof has heavy granule loss and I had to use a drone on the steep parts due to the age. Due to the age you will start to run into issues with insurance.

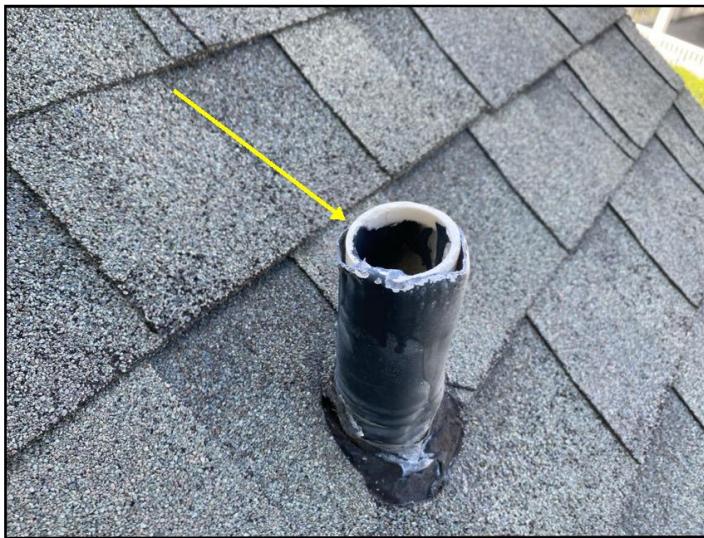
Page 12 Item: 2	Flashing	<ul style="list-style-type: none"> <li>The plumbing vents showed signs of damage from squirrels. Squirrels like to chew on the lead flashing and can eventually make a hole large enough to cause a leak. I recommend having plastic vent covers placed on the vents to protect them from damage.</li> </ul>
-----------------	----------	--------------------------------------------------------------------------------------------------------------------------------------------------------------------------------------------------------------------------------------------------------------------------------------------------------------

- The plumbing vents showed signs of damage from squirrels. Squirrels like to chew on the lead flashing and can eventually make a hole large enough to cause a leak. I recommend having plastic vent covers placed on the vents to protect them from damage.

There is a chewed up plumbing vent on the right side from squirrels. I would seal around the pipe and put covers over them.

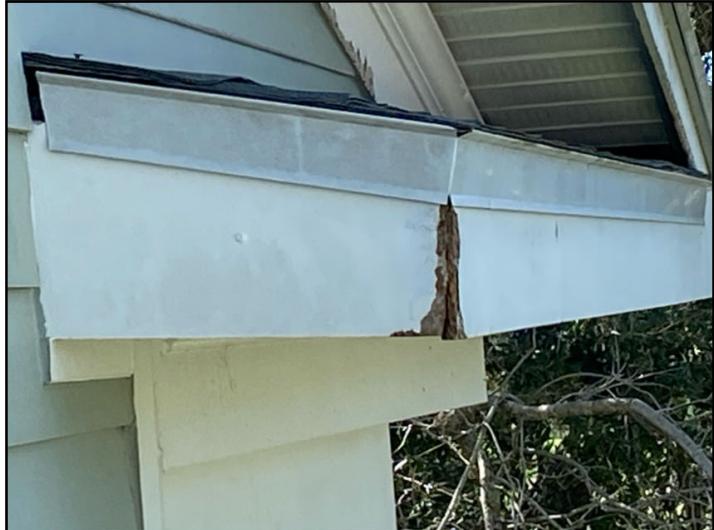
- The fascia needs to be painted in places to prevent damage. The Inspector recommends repair by a qualified painter.
- One or more screens for the soffit vents were damaged. These are to prevent rodents from entering the attic. Recommend repair.

There is some fascia with minor damage to it on the left side. I would have this painted so it doesn't decay further.

It's hard to see but there is an opening in the soffit over this area on the left. It should be sealed up.

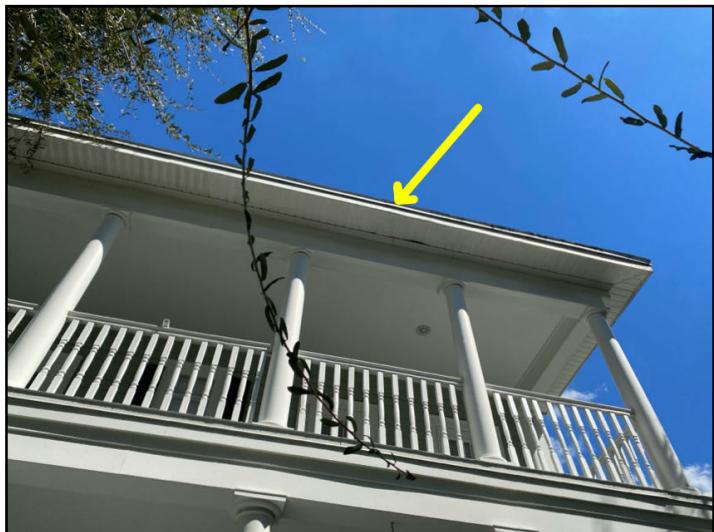
There is a loose soffit screen over the front that needs to be put back in place.

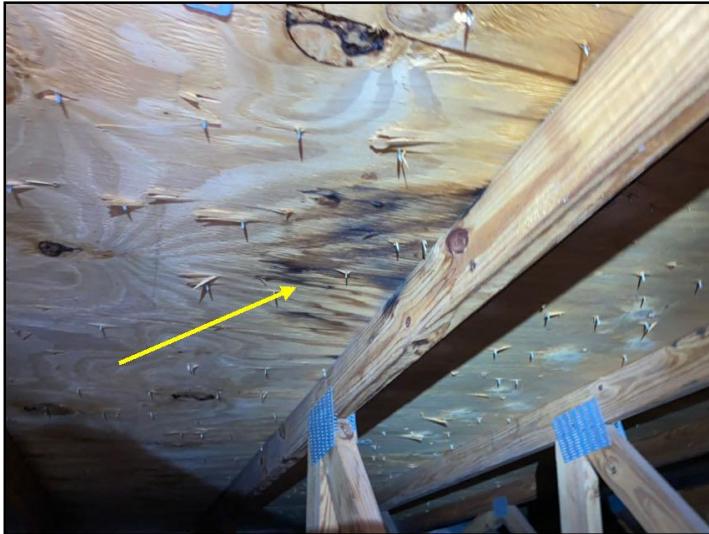
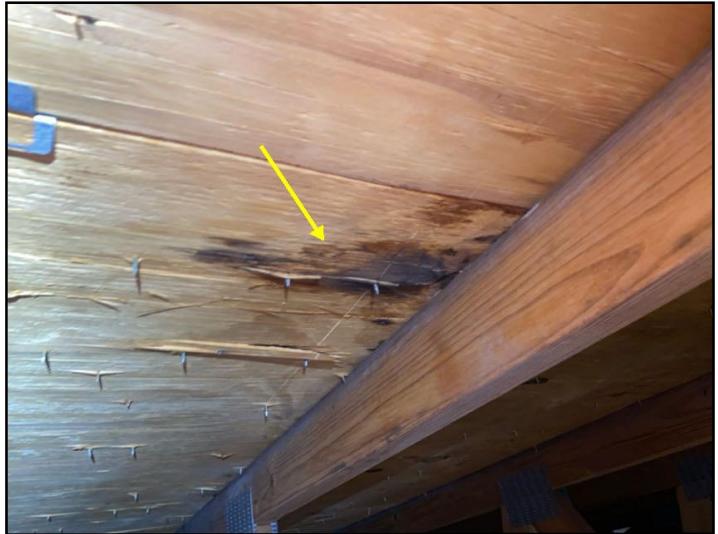
Page 16 Item: 3	Roof Sheathing	<ul style="list-style-type: none"> <li>Roof sheathing had areas of discoloration that appeared to be the result of roof leakage. Moisture meter testing showed no elevated moisture levels in affected areas at the time of the inspection. Either the source of the leak has been corrected, or the lack of recent rain may have allowed sufficient time for the sheathing to dry. The Inspector recommends that before the expiration of your Inspection Objection Deadline that this area be leak-tested by a qualified roofing contractor to determine the chances for future leakage.</li> </ul>
-----------------	----------------	-------------------------------------------------------------------------------------------------------------------------------------------------------------------------------------------------------------------------------------------------------------------------------------------------------------------------------------------------------------------------------------------------------------------------------------------------------------------------------------------------------------------------------------------------------------------------------------------------------

- Roof sheathing had areas of discoloration that appeared to be the result of roof leakage. Moisture meter testing showed no elevated moisture levels in affected areas at the time of the inspection. Either the source of the leak has been corrected, or the lack of recent rain may have allowed sufficient time for the sheathing to dry. The Inspector recommends that before the expiration of your Inspection Objection Deadline that this area be leak-tested by a qualified roofing contractor to determine the chances for future leakage.

There were a handful of stains on the sheathing. They all tested dry but we haven't had a lot of rain in the last few days. The sheathing will dry out quickly. You may want to have the roof leak tested.

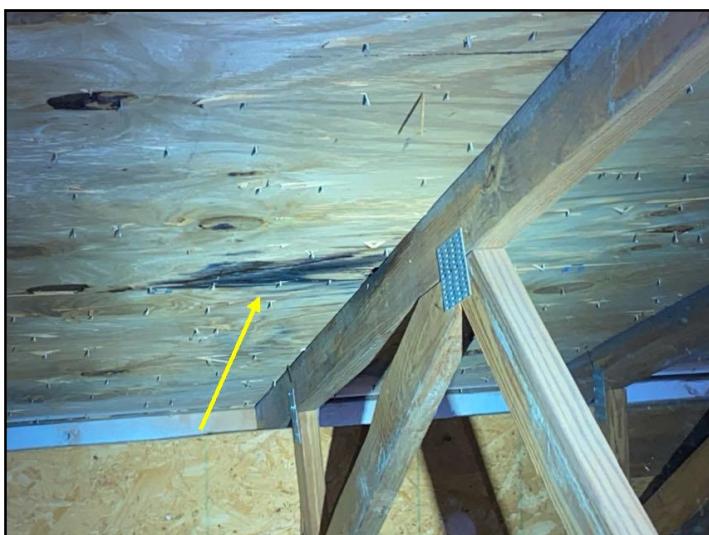
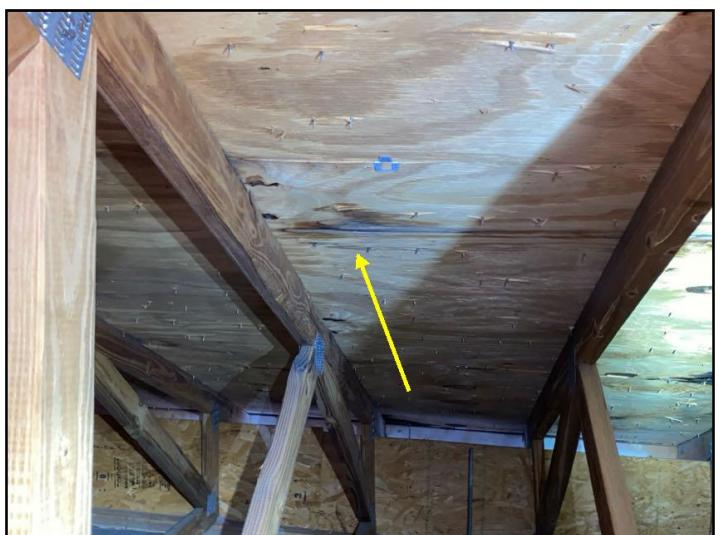
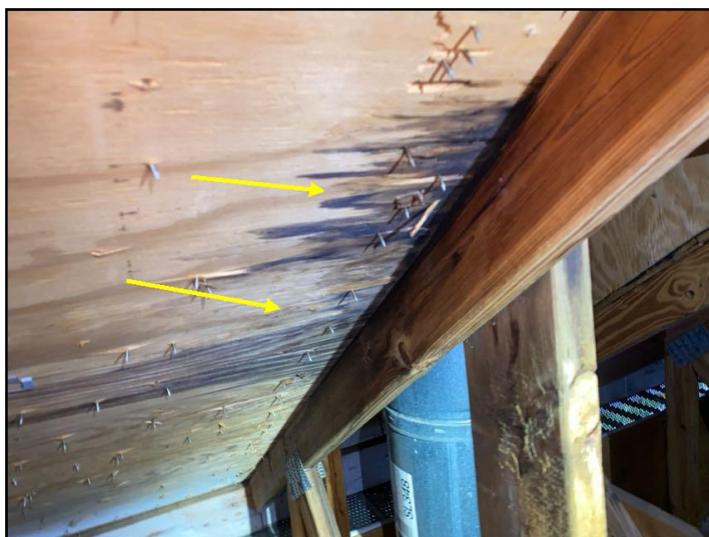
There are a lot of stains around the chimney.

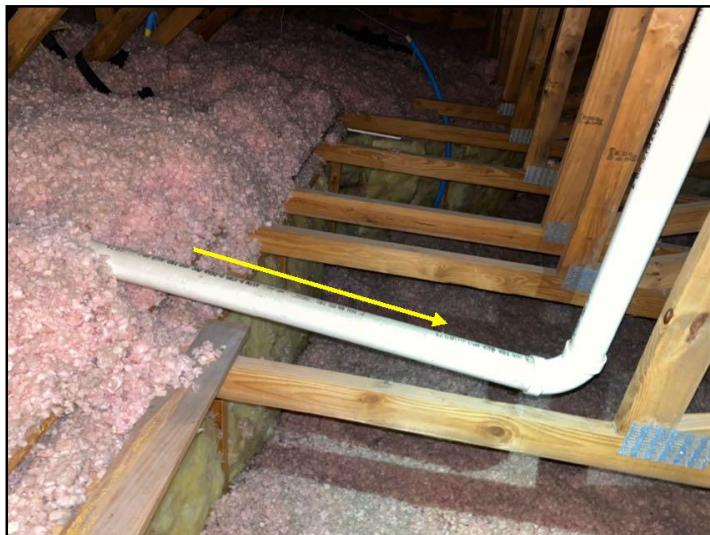
- Plumbing vent pipes visible in the attic had inadequate slope. The Inspector recommends correction by a qualified contractor.

This plumbing vent in the attic is sloped downwards. This needs to be sloped up so it doesn't hold water.

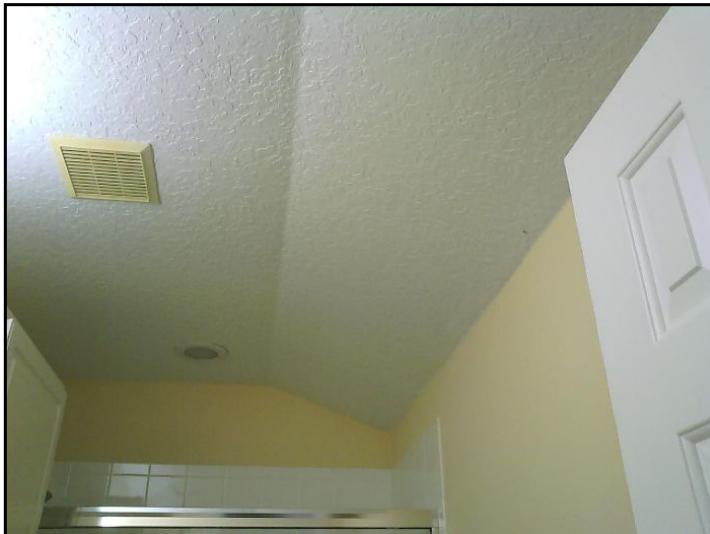
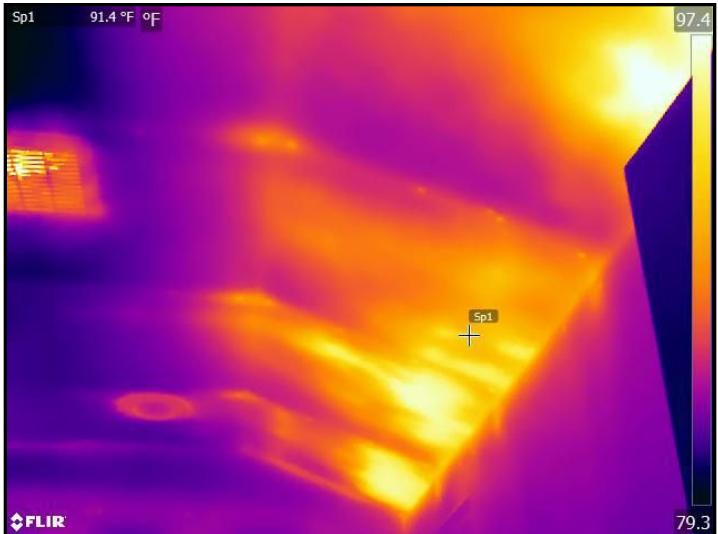
- The attic was missing insulation over areas of significant size. This condition can result in increased heating and cooling costs and reduced comfort levels. The Inspector recommends that insulation be properly distributed to cover all portions of the attic located above the home living space. All work should be performed by a qualified contractor.

Gaps in the insulation over bathroom 1

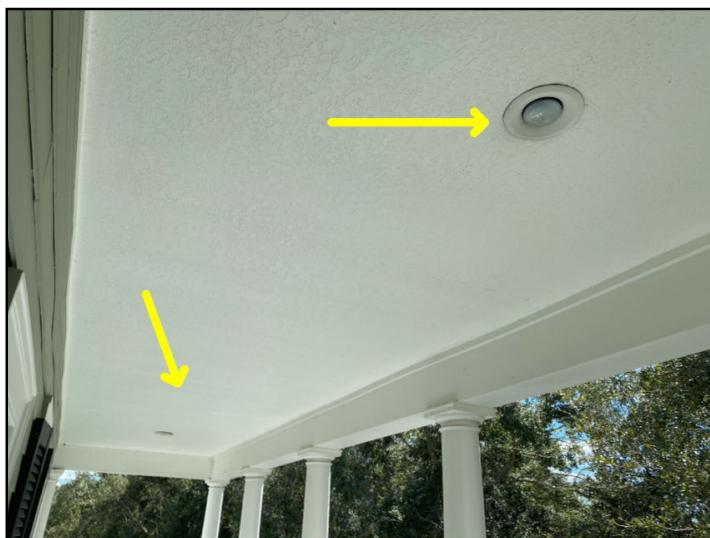
Page 21 Item: 2	Exterior Lighting	<ul style="list-style-type: none"> <li>A light fixture mounted at the balcony was inoperable at the time of the inspection. This condition can be caused by a burned out bulb, or a problem may exist with the light fixture, wiring or the switch. This light fixture should be re-tested after the bulb is replaced. If after bulb replacement the light still fails to respond to the switch, this condition may be a potential fire hazard, and an inspection and any necessary work should be performed by a qualified electrical contractor.</li> </ul>
-----------------	-------------------	---------------------------------------------------------------------------------------------------------------------------------------------------------------------------------------------------------------------------------------------------------------------------------------------------------------------------------------------------------------------------------------------------------------------------------------------------------------------------------------------------------------------------------------------------------------

- A light fixture mounted at the balcony was inoperable at the time of the inspection. This condition can be caused by a burned out bulb, or a problem may exist with the light fixture, wiring or the switch. This light fixture should be re-tested after the bulb is replaced. If after bulb replacement the light still fails to respond to the switch, this condition may be a potential fire hazard, and an inspection and any necessary work should be performed by a qualified electrical contractor.

The lights at the balcony did not work. The bulbs are most likely just burned out.

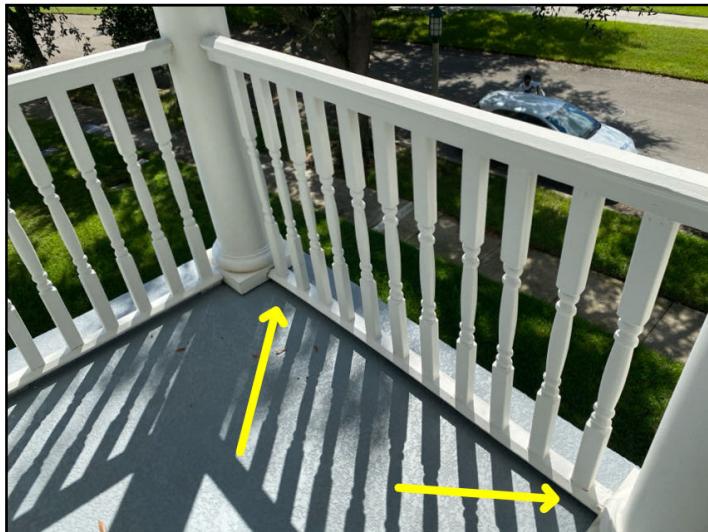
Page 22 Item: 5	Balcony/Deck	<ul style="list-style-type: none"> <li>Balcony guardrail assemblies were loose and should be made secure by a qualified contractor.</li> </ul>
-----------------	--------------	------------------------------------------------------------------------------------------------------------------------------------------------

- Balcony guardrail assemblies were loose and should be made secure by a qualified contractor.

The bottom of this guard rail is not secure.

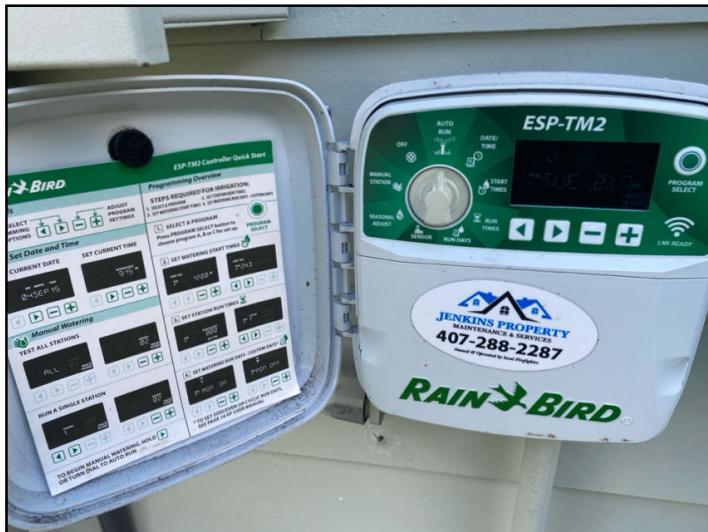
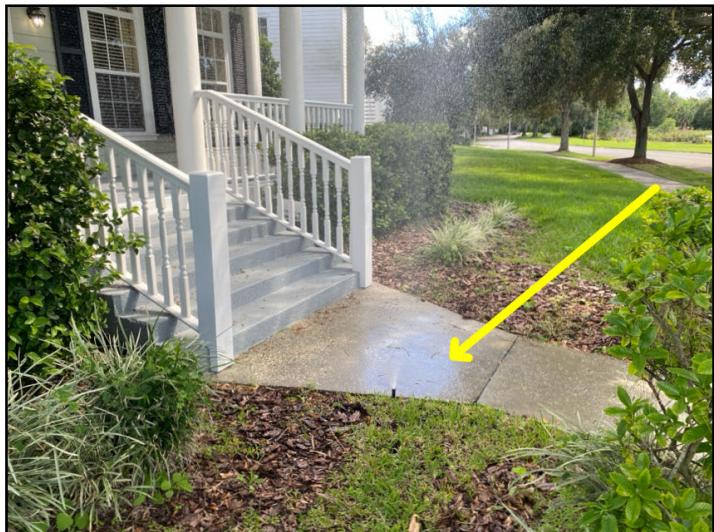
- The inspector noted a broken sprinkler head. These should be replaced to avoid wasting water. All work should be performed by a qualified contractor.

Broken head

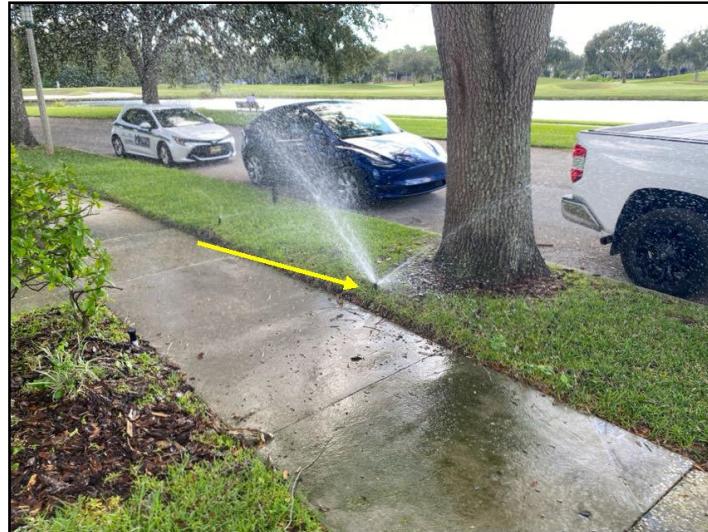
Broken head

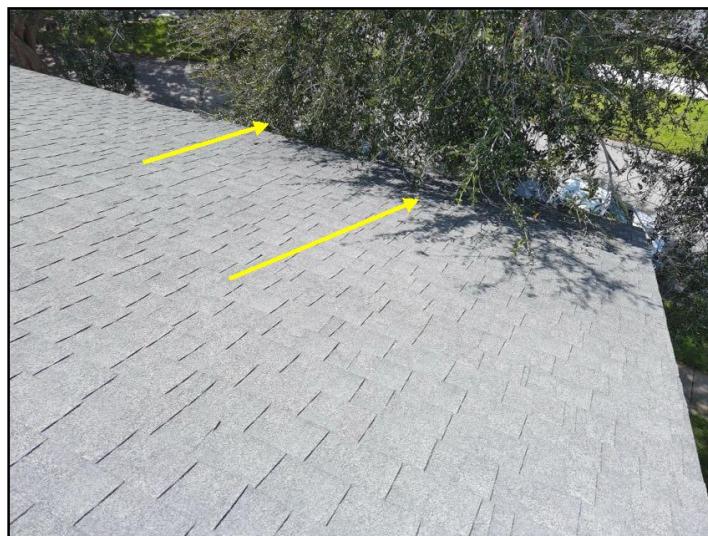
- The tree branches overhung the roof and need to be cut back to prevent damage to the shingles.

I would trim back these tree limbs at the front so they don't rub on the shingles.

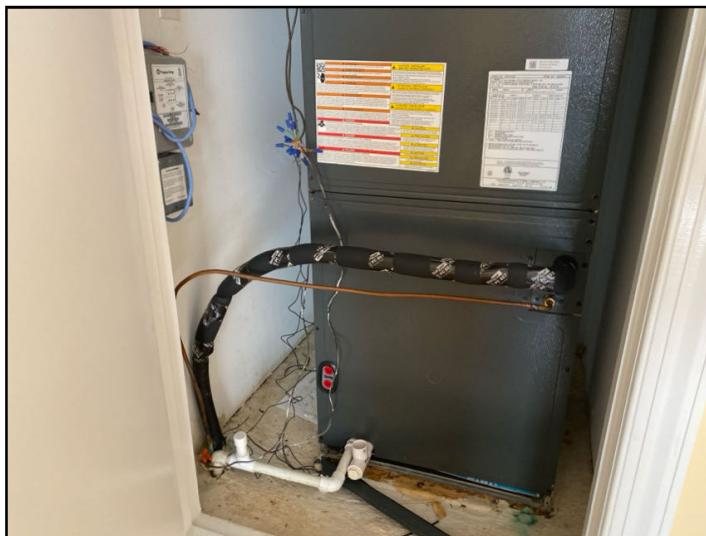
Downstairs unit

Page 30 Item: 2	Air Handler	<ul style="list-style-type: none"> <li>The evaporator coils and blower were dirty and need to be cleaned. Failure to keep these items maintained can lead to higher energy costs and shortened life expectancy of the HVAC system. Recommend cleaning by a licensed HVAC technician.</li> <li>The inspector noted that the HVAC system did not produce adequate heat when tested. This is an indication that there is an issue with the heat strips or heat pump. Recommend having the system repaired by a licensed HVAC technician.</li> <li>The emergency shut-off switch for the air handler did not function properly. Recommend having this unit replaced. Recommend all repairs be made by a qualified HVAC technician.</li> </ul>
Page 35 Item: 5	Duct Work	<ul style="list-style-type: none"> <li>Ducts in the attic were leaking air at the time of the inspection. The Inspector recommends correction by a qualified contractor to save on energy costs.</li> </ul>

- The evaporator coils and blower were dirty and need to be cleaned. Failure to keep these items maintained can lead to higher energy costs and shortened life expectancy of the HVAC system. Recommend cleaning by a licensed HVAC technician.
- The inspector noted that the HVAC system did not produce adequate heat when tested. This is an indication that there is an issue with the heat strips or heat pump. Recommend having the system repaired by a licensed HVAC technician.
- The emergency shut-off switch for the air handler did not function properly. Recommend having this unit replaced. Recommend all repairs be made by a qualified HVAC technician.
- The Inspector noted that the area around the air handler had moisture damage from what appears to have been a condensate backup. Recommend having the area repaired by a licensed contractor.

The coils and blower blades are a little dirty and could use a cleaning

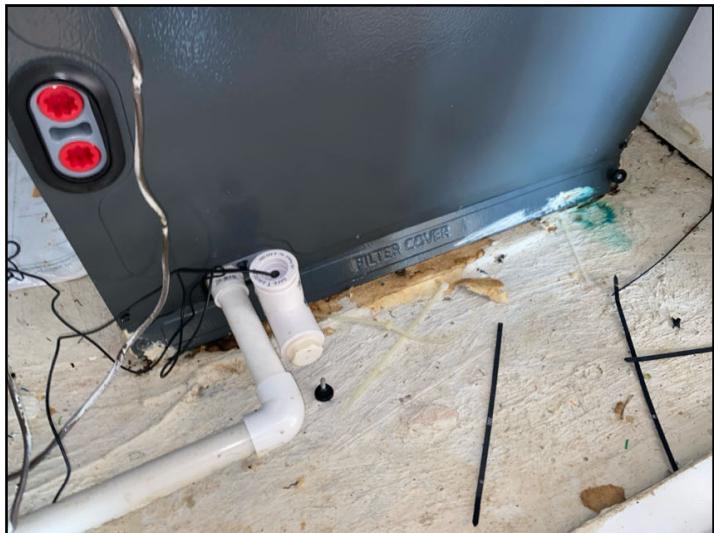
There are stains on the flooring around the downstairs unit from past leaks. The flooring is bowed downwards due to this.

I would caulk around the duct that goes into the attic so you aren't pulling in hot/humid attic air.

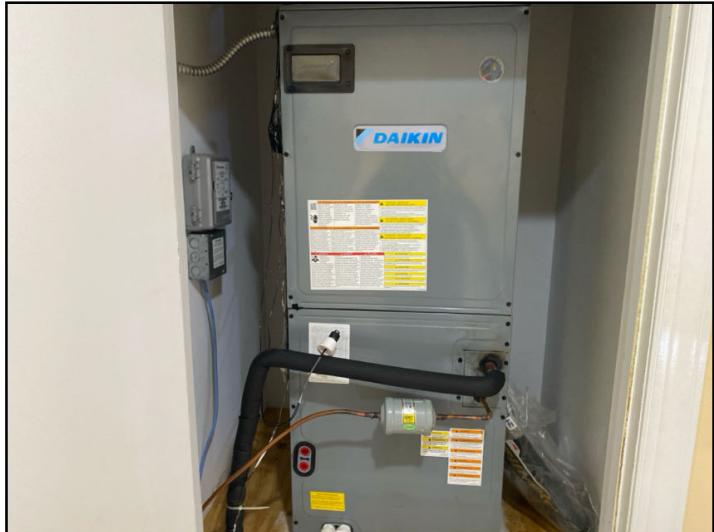
Upstairs unit

The coils are a little dirty and could use a cleaning

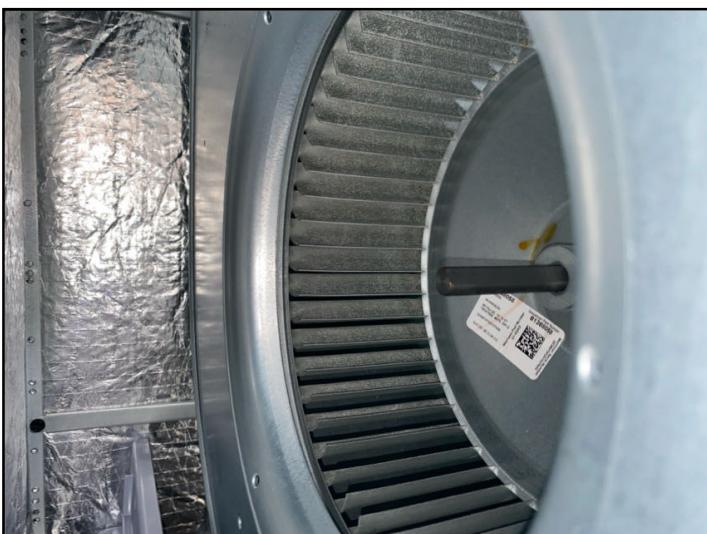
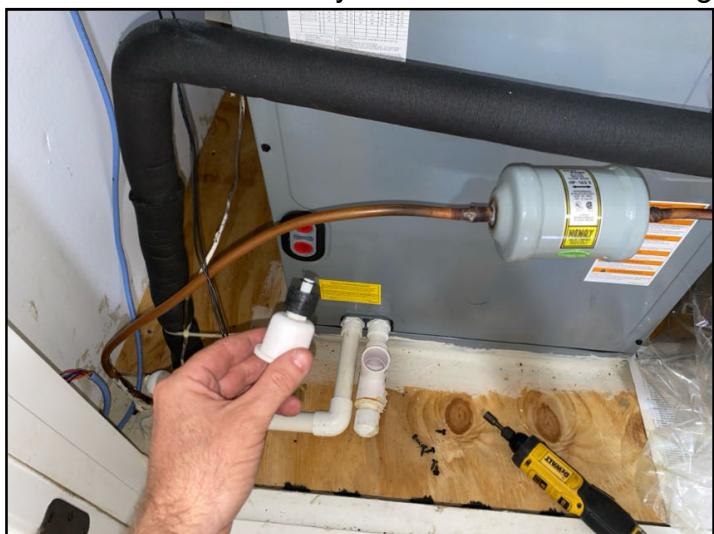
The emergency shutoff switch for the upstairs unit does not work and should be replaced.

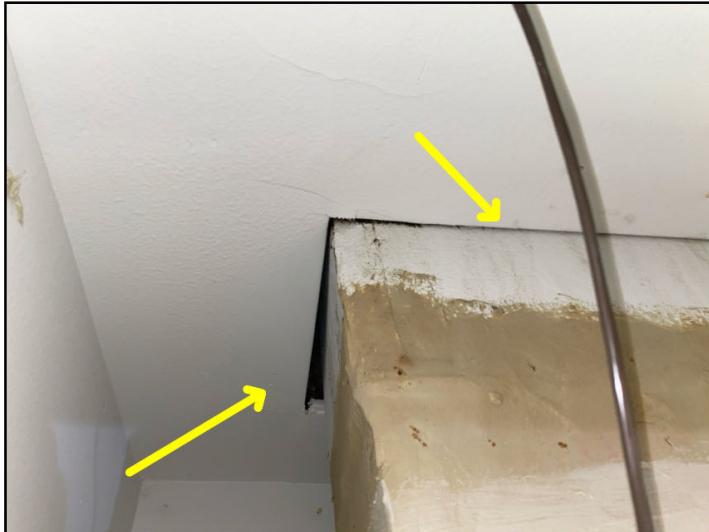
Seal around the duct

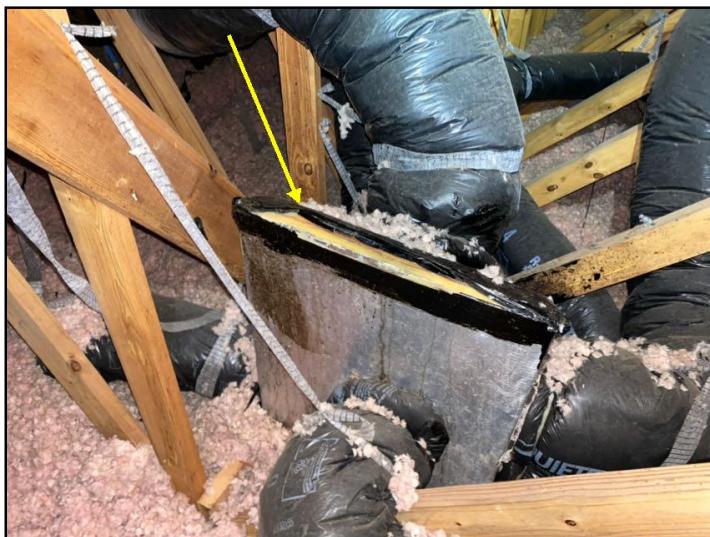
- Ducts in the attic were leaking air at the time of the inspection. The Inspector recommends correction by a qualified contractor to save on energy costs.
- The Flexduct was not properly supported. This can cause restrictions in air flow and increase heating and cooling cost. Recommend repair by a qualified HVAC technician.
- Some of the flex duct installed had sharp bends. This will reduce airflow to these rooms. Recommend correction by a licensed hvac technician.

This duct plenum is leaking a lot of air. This needs to be sealed up.

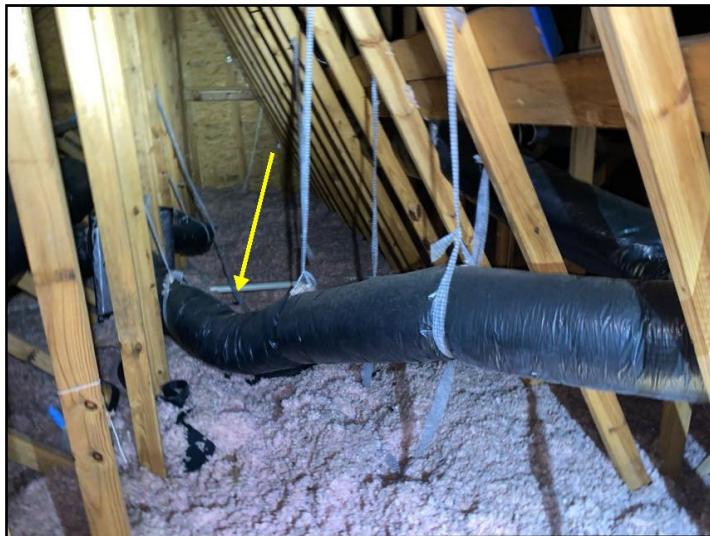
Portions of the ductwork have sags and need to be supported. Sags will reduce airflow

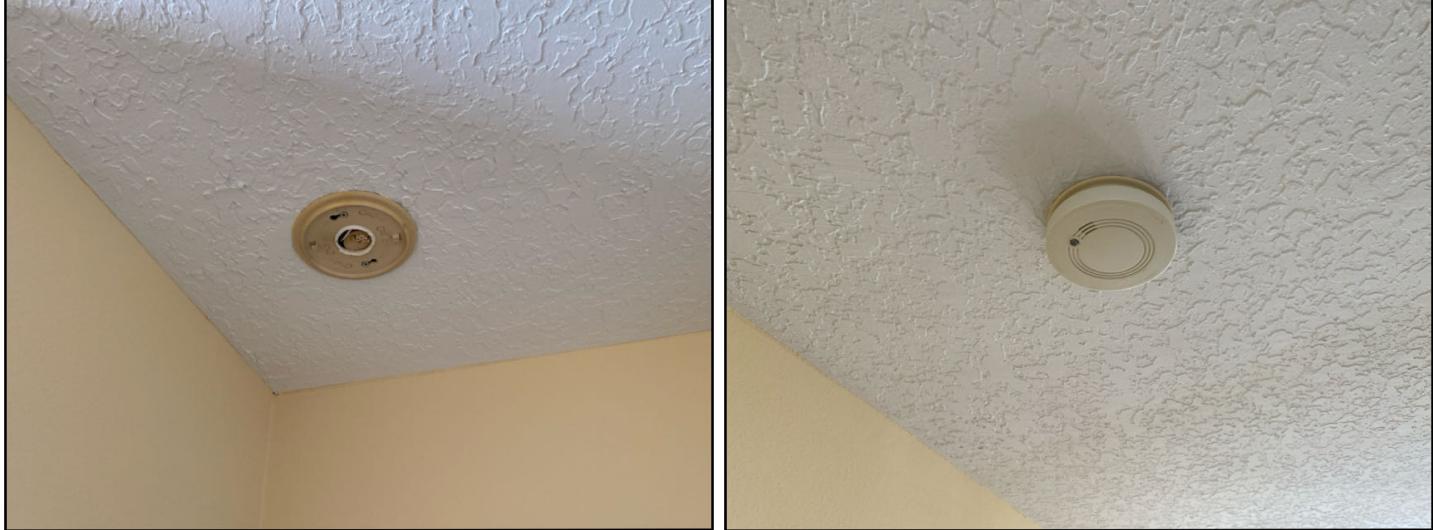
Page 41 Item: 4	Smoke Detectors	<ul style="list-style-type: none"> <li>The smoke detectors protecting sleeping areas were older and may not be functional. Although testing of smoke detectors lies beyond the scope of the General Home Inspection, the Inspector recommends that you have this and any other older smoke detectors tested and maintained, upgraded or replaced as needed. Hardwired smoke detectors should be replaced by a qualified electrical contractor.</li> <li>The inspector noted that the home had areas with missing smoke detectors. Recommend replacement.</li> </ul>
-----------------	-----------------	---------------------------------------------------------------------------------------------------------------------------------------------------------------------------------------------------------------------------------------------------------------------------------------------------------------------------------------------------------------------------------------------------------------------------------------------------------------------------------------------------------------------------------------------------------------------

- The smoke detectors protecting sleeping areas were older and may not be functional. Although testing of smoke detectors lies beyond the scope of the General Home Inspection, the Inspector recommends that you have this and any other older smoke detectors tested and maintained, upgraded or replaced as needed. Hardwired smoke detectors should be replaced by a qualified electrical contractor.
- The inspector noted that the home had areas with missing smoke detectors. Recommend replacement.

There are a few missing smoke detectors

The ones that are in the house are original and should be replaced.

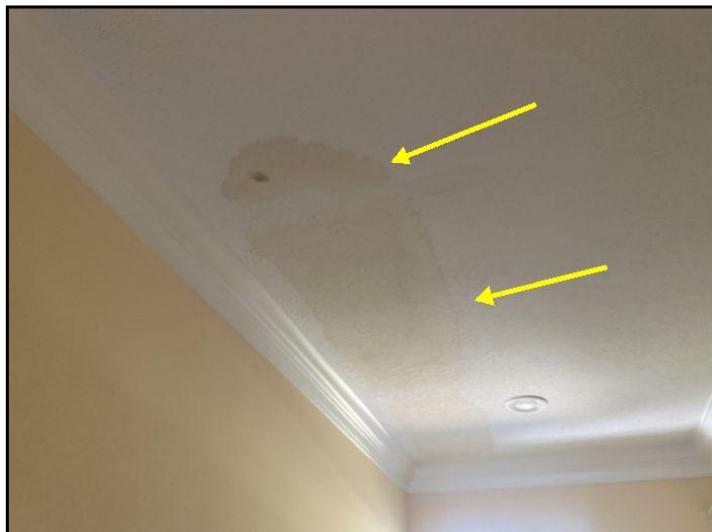
Page 42 Item: 6	Floors/Ceiling/Wall's Condition	<ul style="list-style-type: none"> <li>Stains on the ceiling visible at the time of the inspection appeared to be the result of leakage from plumbing fixtures or pipes located in or at the floor above. The moisture meter showed elevated levels of moisture present in the affected areas, indicating that the leakage had been recent. The Inspector recommends that before the expiration of your Inspection Objection Deadline you consult with a qualified contractor to discuss options and costs for correction and repair.</li> </ul>
-----------------	---------------------------------	--------------------------------------------------------------------------------------------------------------------------------------------------------------------------------------------------------------------------------------------------------------------------------------------------------------------------------------------------------------------------------------------------------------------------------------------------------------------------------------------------------------------------------------------------

- Stains on the ceiling visible at the time of the inspection appeared to be the result of leakage from plumbing fixtures or pipes located in or at the floor above. The moisture meter showed elevated levels of moisture present in the affected areas, indicating that the leakage had been recent. The source of leakage should be identified and corrected. The Inspector recommends that before the expiration of your Inspection Objection Deadline you consult with a qualified contractor to discuss options and costs for correction and repair.

Stains on the ceiling above the front entryway.

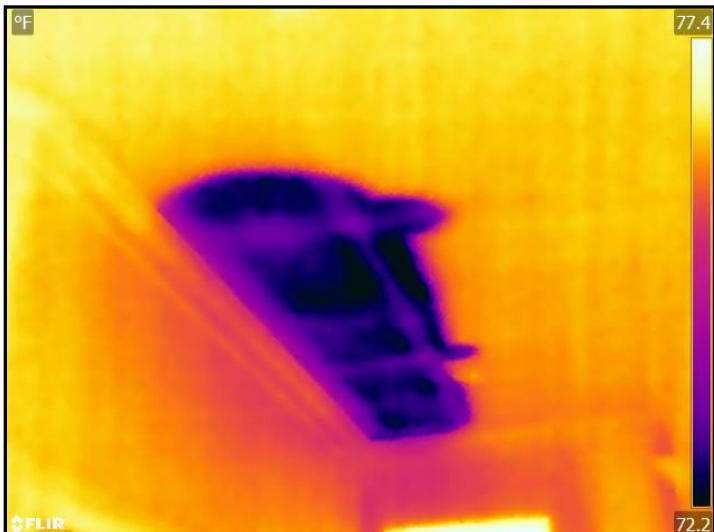
Thermal showing the spot is wet. This is below the bathroom above.

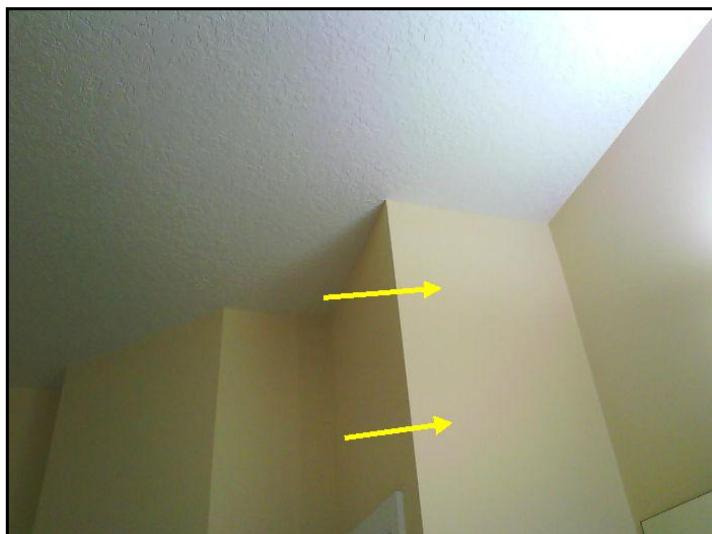
Leak detected coming down the wall in the master bathroom.

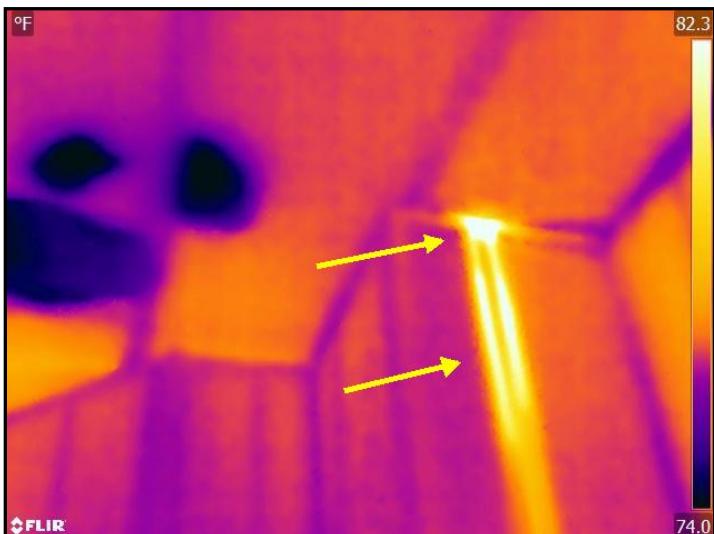
Thermal showing the hot water coming down the wall from the shower.

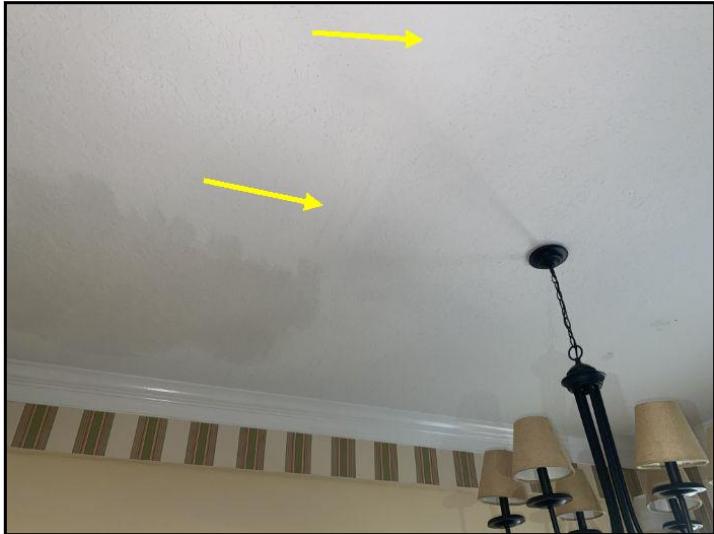
There is a stain on the ceiling in the dining room. The spot was wet when tested today.

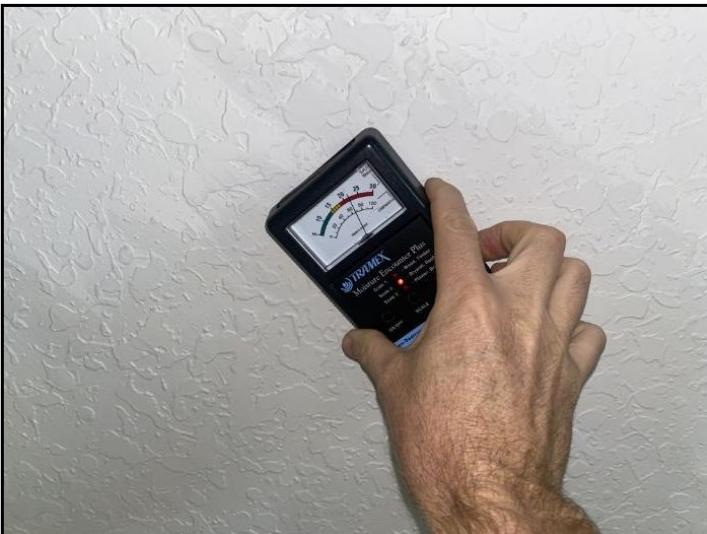
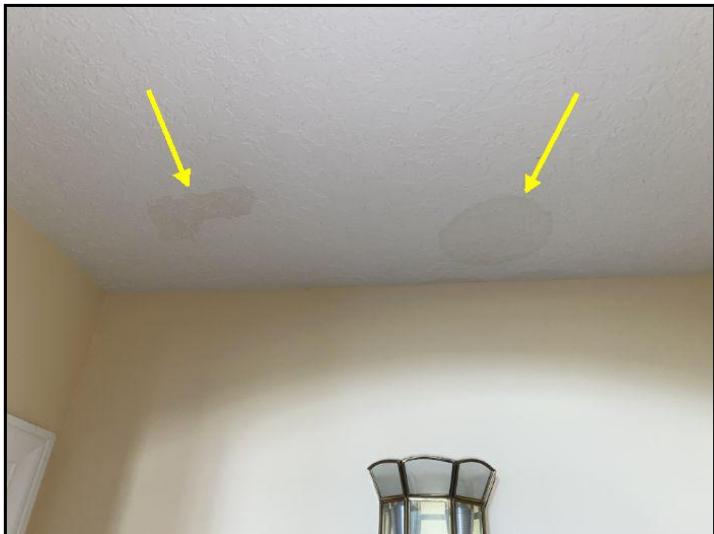
The two spots below the downstairs air handler are dry. This may have been from a past condensate line backup.

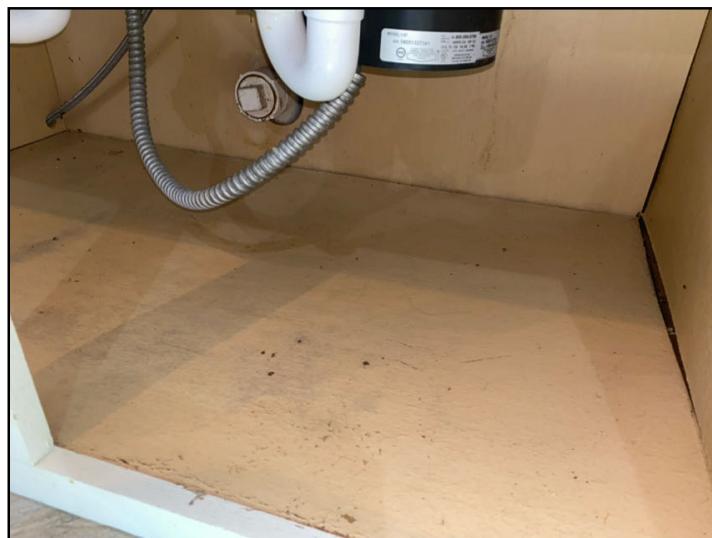
Page 45 Item: 2	Cabinets/Counters	<ul style="list-style-type: none"> <li>The floor of the kitchen sink cabinet exhibited damage from past moisture intrusion. Recommend repair by a licensed contractor.</li> </ul>
-----------------	-------------------	-----------------------------------------------------------------------------------------------------------------------------------------------------------------------------------

- The floor of the kitchen sink cabinet exhibited damage from past moisture intrusion. Recommend repair by a licensed contractor.

The bottom of the cabinet below the sink has some damage from past leaks.

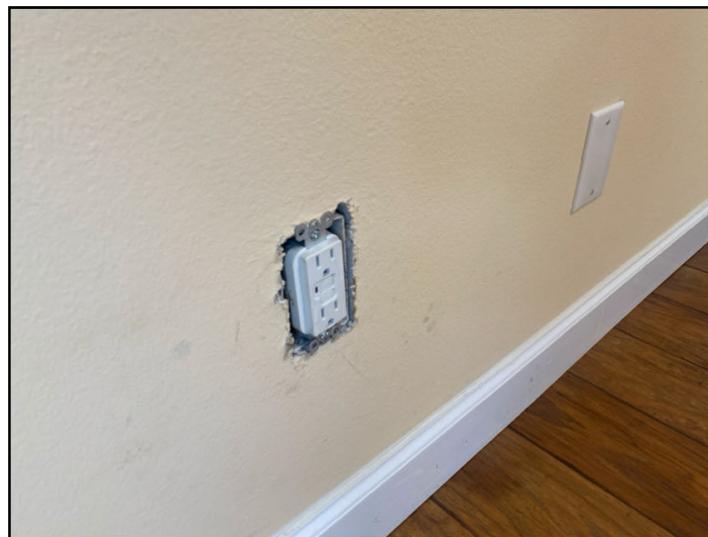
Page 48 Item: 3	Electrical	<ul style="list-style-type: none"> <li>An electrical receptacle in this bedroom had a damaged or missing a cover plate. This condition left energized electrical components exposed to touch. This shock/electrocution hazard should be corrected by a qualified electrical contractor.</li> </ul>
-----------------	------------	----------------------------------------------------------------------------------------------------------------------------------------------------------------------------------------------------------------------------------------------------------------------------------------------------

- An electrical receptacle in this bedroom had a damaged or missing a cover plate. This condition left energized electrical components exposed to touch. This shock/electrocution hazard should be corrected by a qualified electrical contractor.

A cover plate is needed for this outlet in bedroom 3

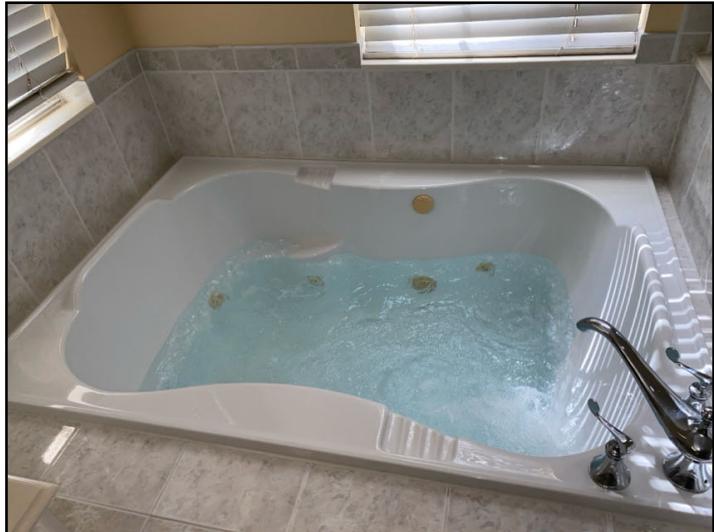
The jetted tub in the master bath works. There is not an access hatch though to get to the pump.

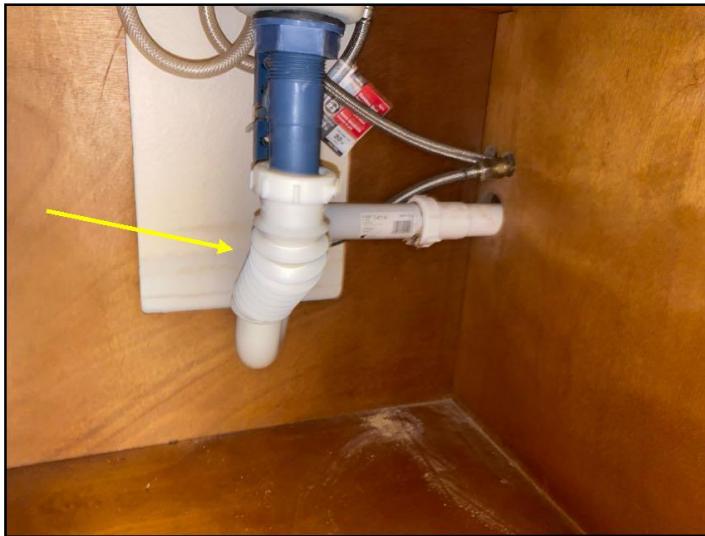
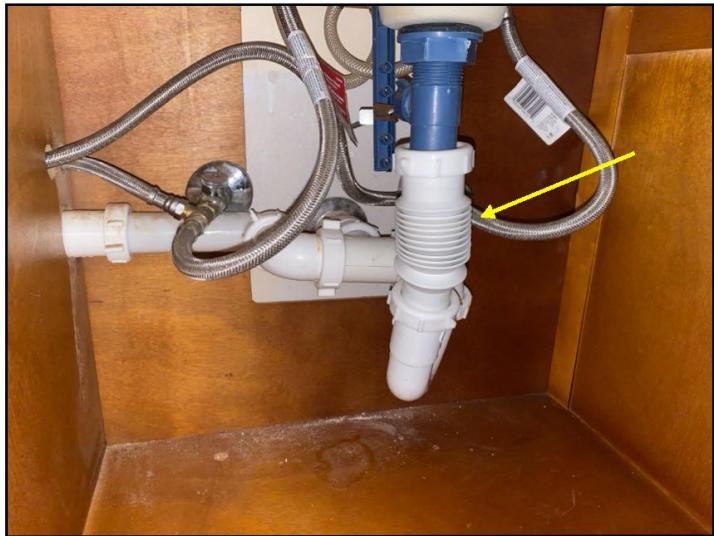
- Flex pipe material was used in part of the drain plumbing. Flex pipe is known to clog and eventually crack causing leaks. It is commonly used by non-professionals due to its ease of installation. Recommend replacing this section with approved PVC material.

Both sinks in the half bath have this cheap flex pipe. I would replace this with standard pvc.

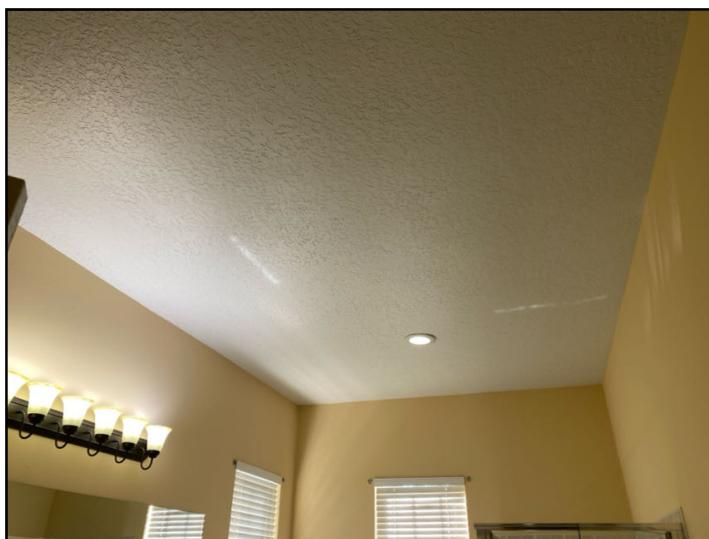
Page 51 Item: 6	Bathroom Ventilation	<ul style="list-style-type: none"><li>• No exhaust fan was provided for a bathroom. To avoid poor conditions resulting from excessively moist air, The Inspector recommends installation of an exhaust fan by a qualified contractor.</li></ul>
-----------------	----------------------	-------------------------------------------------------------------------------------------------------------------------------------------------------------------------------------------------------------------------------------------------

- No exhaust fan was provided for a bathroom. To avoid poor conditions resulting from excessively moist air, The Inspector recommends installation of an exhaust fan by a qualified contractor.

There isn't a vent fan in the main area in the master bathroom. I would have one added

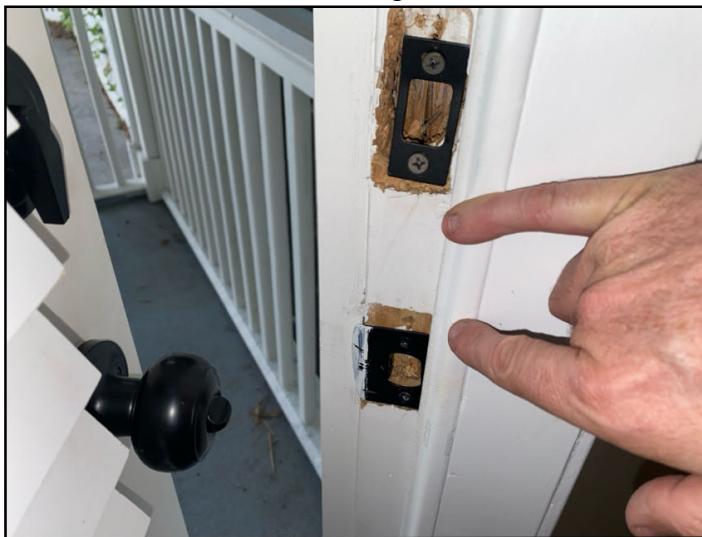
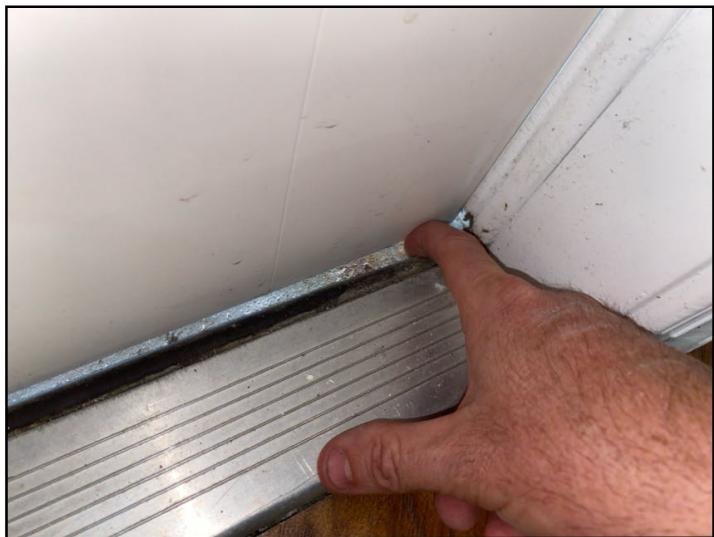
They replaced the strike plates on this door in the master bedroom. This is causing the door to not sit flush against the weather stripping when closed. I would have these adjusted.
