# PROPERTY INSPECTION REPORT

Date of Inspection: 11/25/2025 | Size: 1631 | Weather:

## MEEKS

907 Red Dandy Drive, Orlando, FL

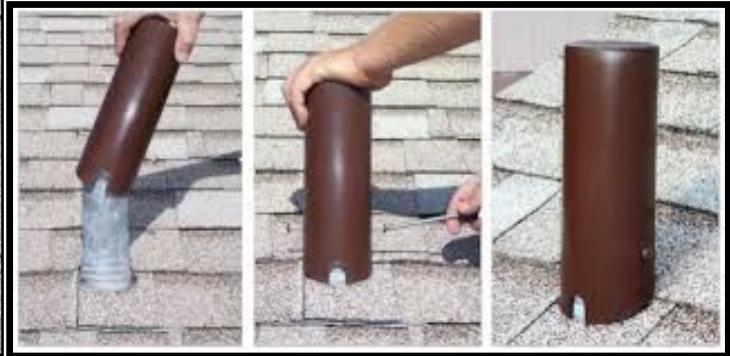
- The plumbing vents showed signs of damage from squirrels. Squirrels like to chew on the lead flashing and can eventually make a hole large enough to cause a leak. I recommend having plastic vent covers placed on the vents to protect them from damage.

There is a chewed up plumbing vent on the right side from squirrels. I would seal around the pipe and put covers over them.

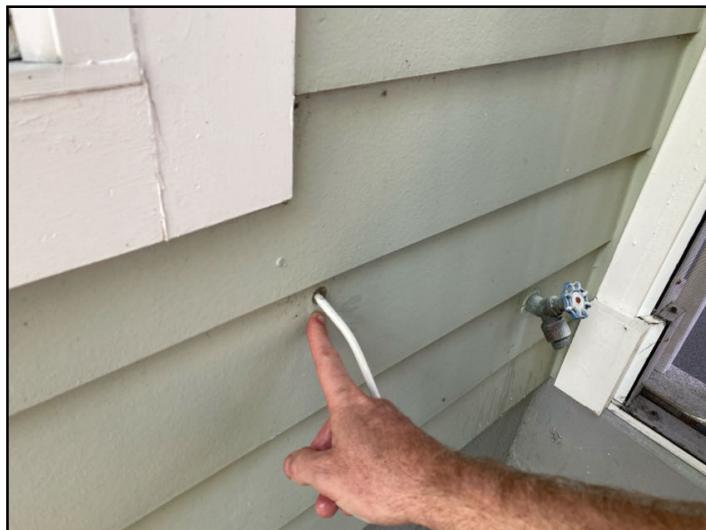
- The home had visible gaps in areas of the siding covering exterior walls. The Inspector recommends application of an appropriate sealant at these areas to help prevent damage from moisture intrusion to the home materials, the exterior wall structure and to prevent development of microbial growth such as mold. All work should be performed by a qualified contractor.

I would caulk this hole at the back right.

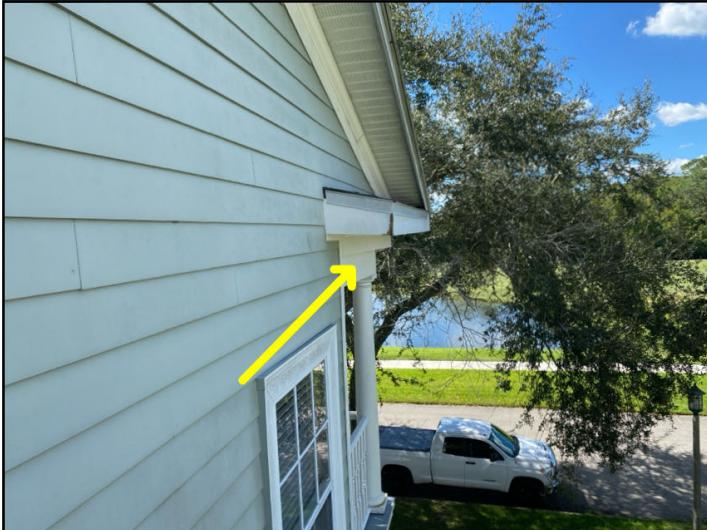
- The fascia needs to be painted in places to prevent damage. The Inspector recommends repair by a qualified painter.
- One or more screens for the soffit vents were damaged. These are to prevent rodents from entering the attic. Recommend repair.

There is some fascia with minor damage to it on the left side. I would have this painted so it doesn't decay further.

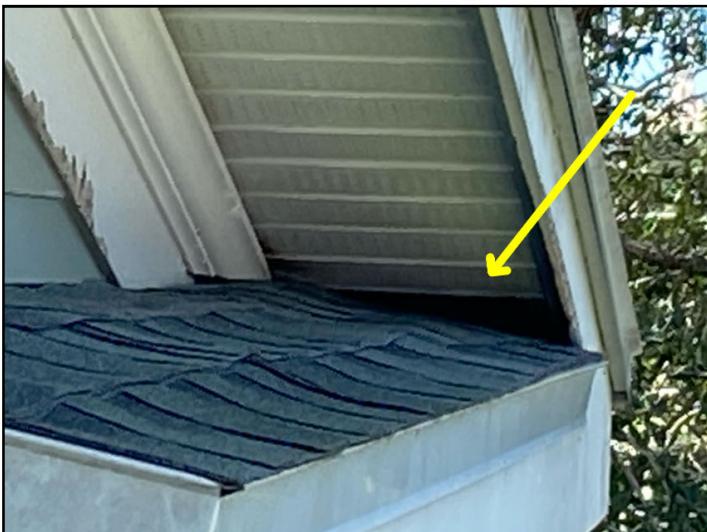
It's hard to see but there is an opening in the soffit over this area on the left. It should be sealed up.

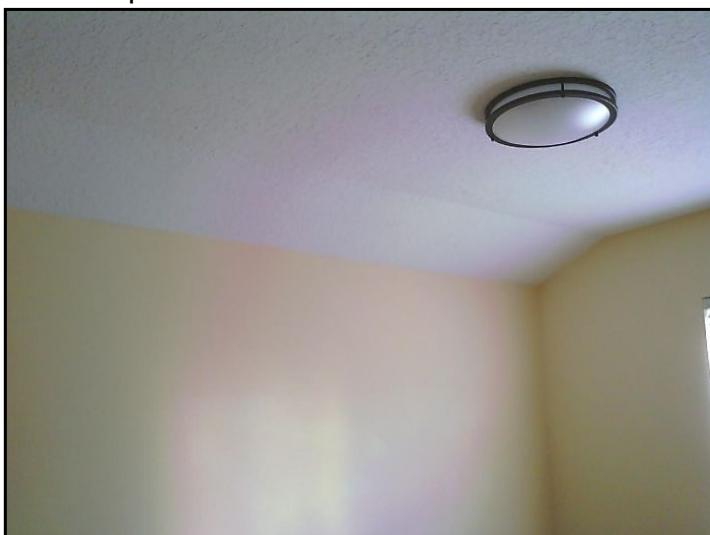
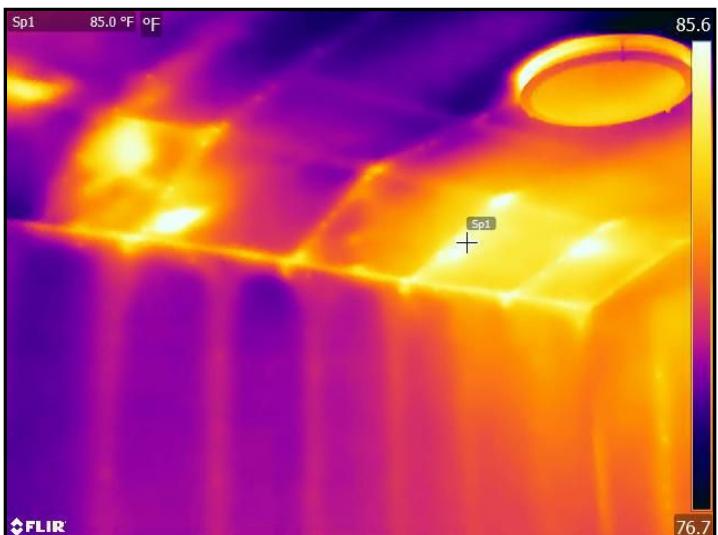
Gaps in insulation over bedroom 3

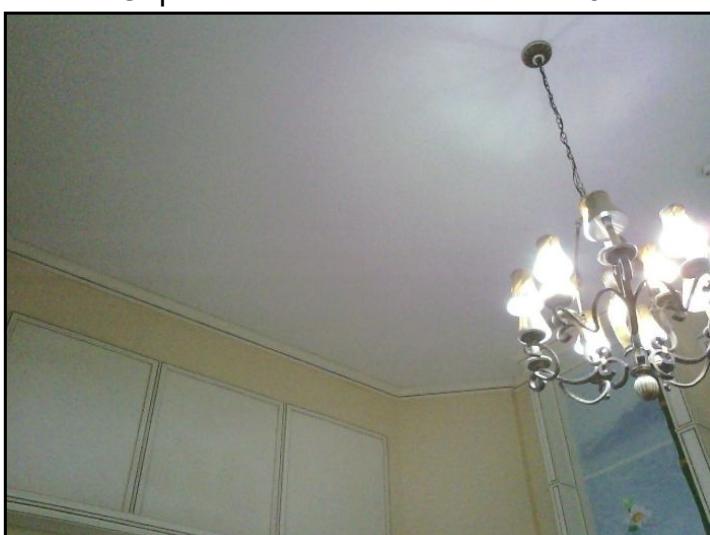
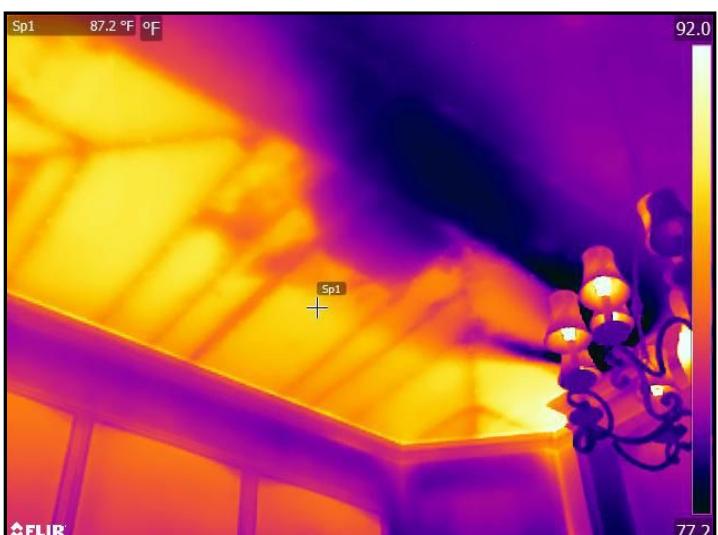
Half of the ceiling in the living room does not have insulation installed.

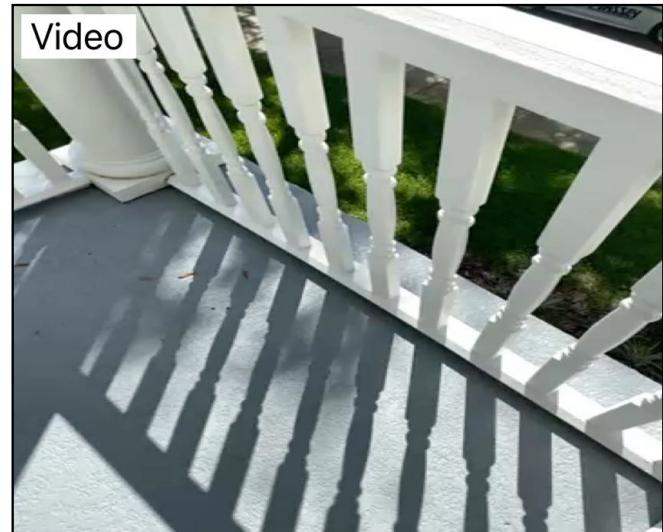
Page 22 Item: 5	Balcony/Deck	<ul style="list-style-type: none"> <li>Balcony guardrail assemblies were loose and should be made secure by a qualified contractor.</li> </ul>
-----------------	--------------	------------------------------------------------------------------------------------------------------------------------------------------------

The bottom of this guard rail is not secure.

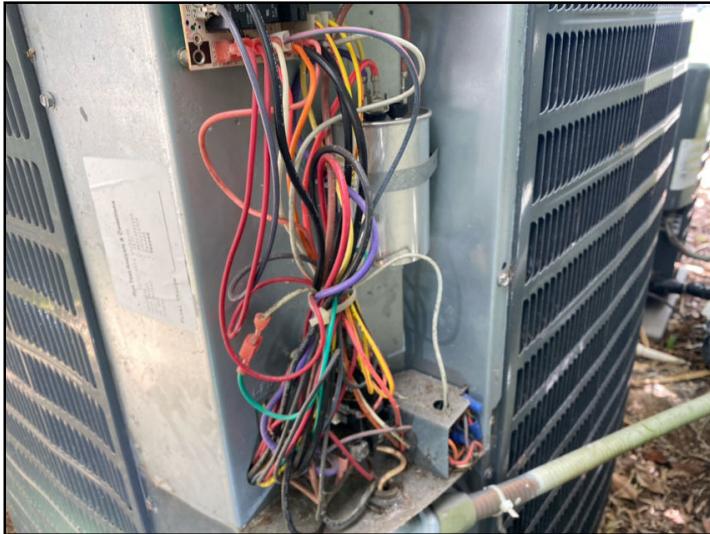
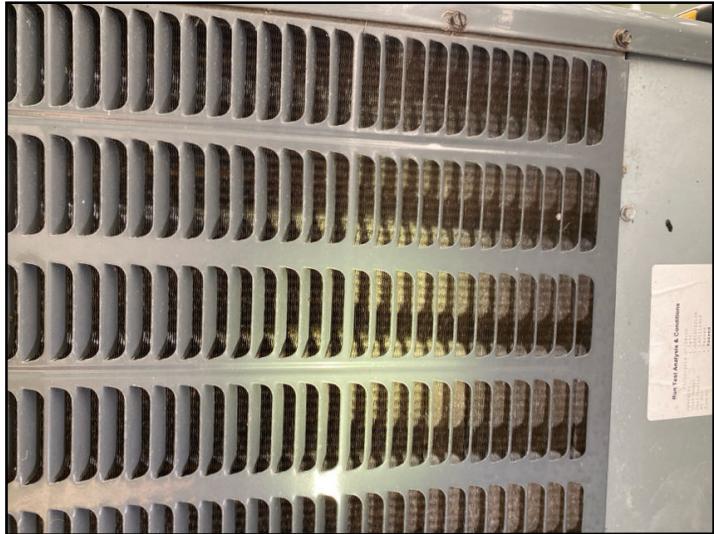
- The coils on the condenser were dirty and in need of cleaning. Dirty coils can lead to reduced system efficiency and put strain on parts such as fan motors & capacitors. Recommend having the unit cleaned by a licensed hvac technician.

Both units have dirty coils that need to be cleaned

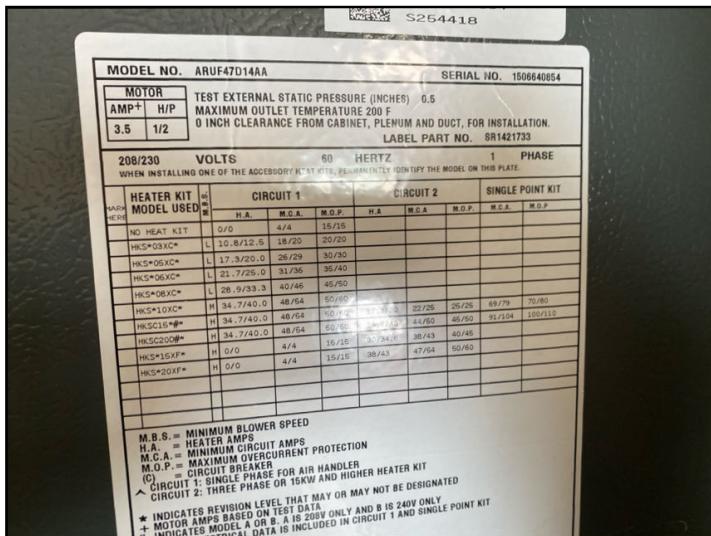
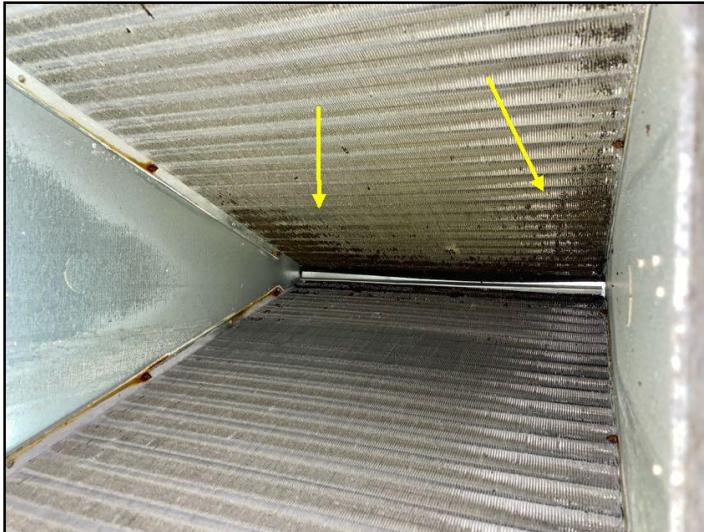
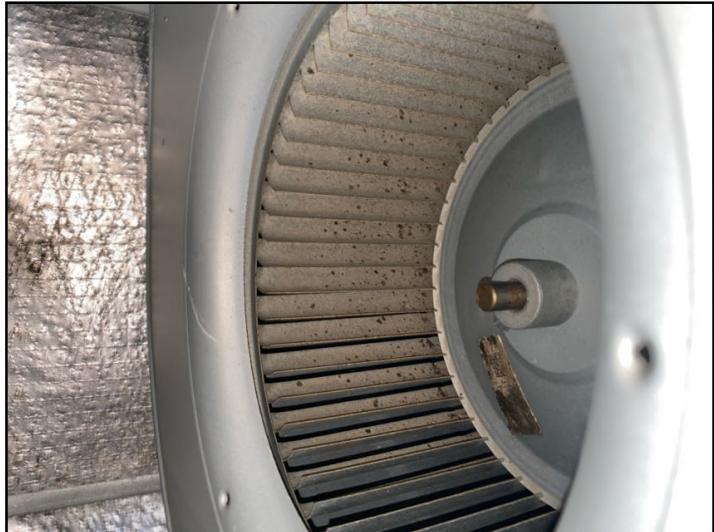
Downstairs unit

- The evaporator coils and blower were dirty and need to be cleaned. Failure to keep these items maintained can lead to higher energy costs and shortened life expectancy of the HVAC system. Recommend cleaning by a licensed HVAC technician.
- The inspector noted that the HVAC system did not produce adequate heat when tested. This is an indication that there is an issue with the heat strips or heat pump. Recommend having the system repaired by a licensed HVAC technician.
- The emergency shut-off switch for the air handler did not function properly. Recommend having this unit replaced. Recommend all repairs be made by a qualified HVAC technician.
- The Inspector noted that the area around the air handler had moisture damage from what appears to have been a condensate backup. Recommend having the area repaired by a licensed contractor.

The coils and blower blades are a little dirty and could use a cleaning

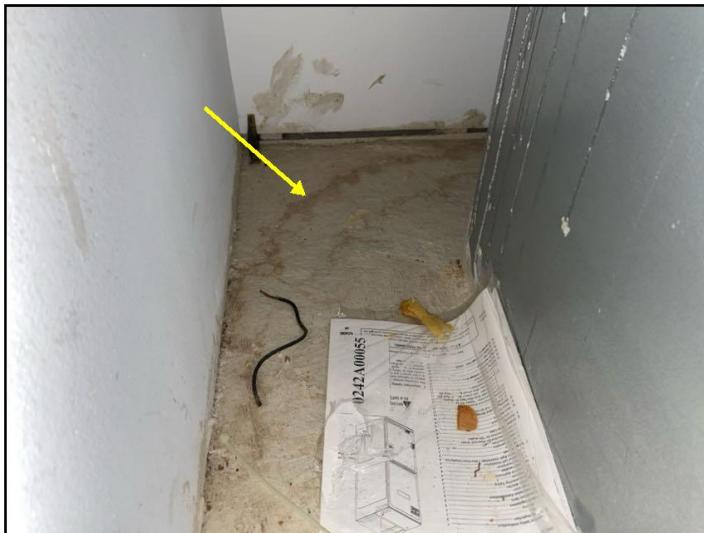
There are stains on the flooring around the downstairs unit from past leaks. The flooring is bowed downwards due to this.

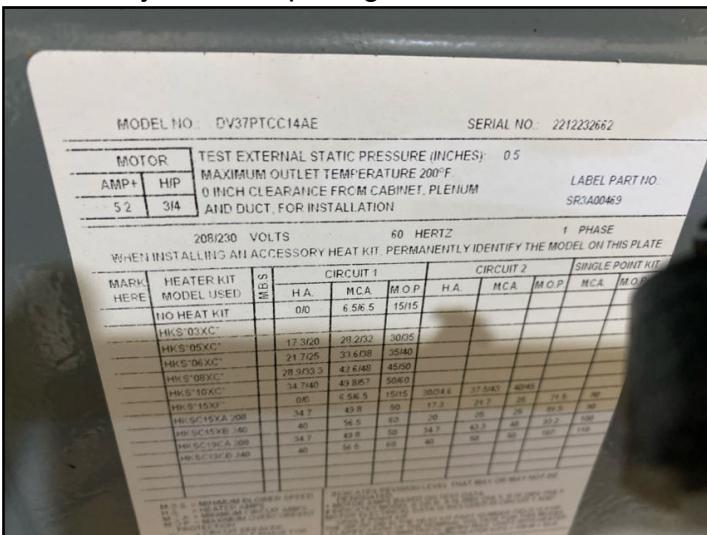
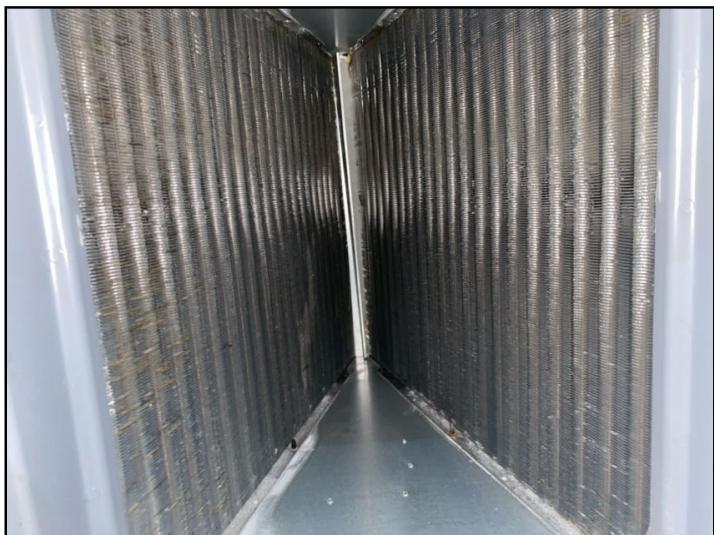
Upstairs unit

The coils are a little dirty and could use a cleaning

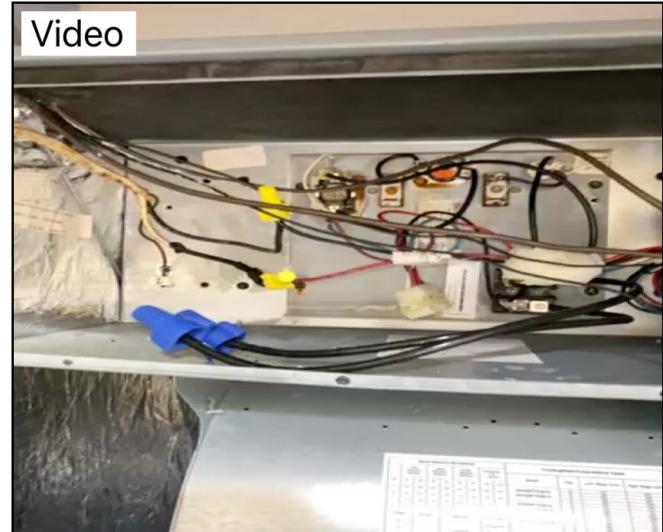
Video showing the upstairs unit does not appear to be wired up properly. They are using the wire harness that you would use if there were not heat strip kit installed but there is a heat kit.

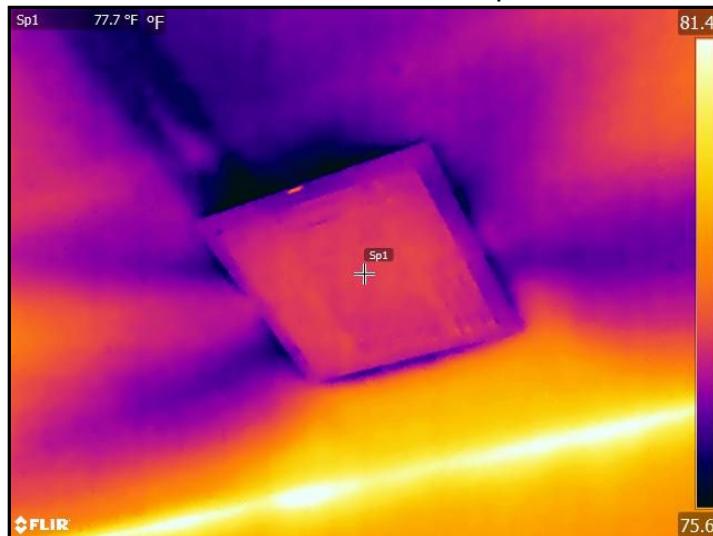
The upstairs unit turned on but no heat came out when testing in heat mode.

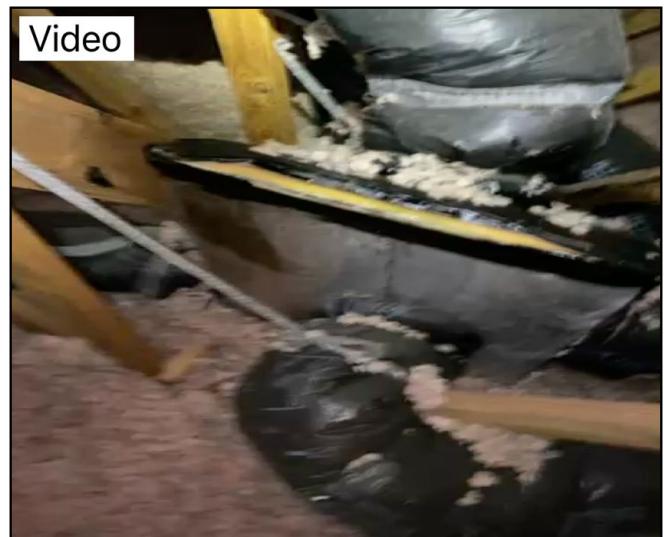
- Ducts in the attic were leaking air at the time of the inspection. The Inspector recommends correction by a qualified contractor to save on energy costs.
- The Flexduct was not properly supported. This can cause restrictions in air flow and increase heating and cooling cost. Recommend repair by a qualified HVAC technician.
- Some of the flex duct installed had sharp bends. This will reduce airflow to these rooms. Recommend correction by a licensed hvac technician.

This duct plenum is leaking a lot of air. This needs to be sealed up.

Video showing the air leak

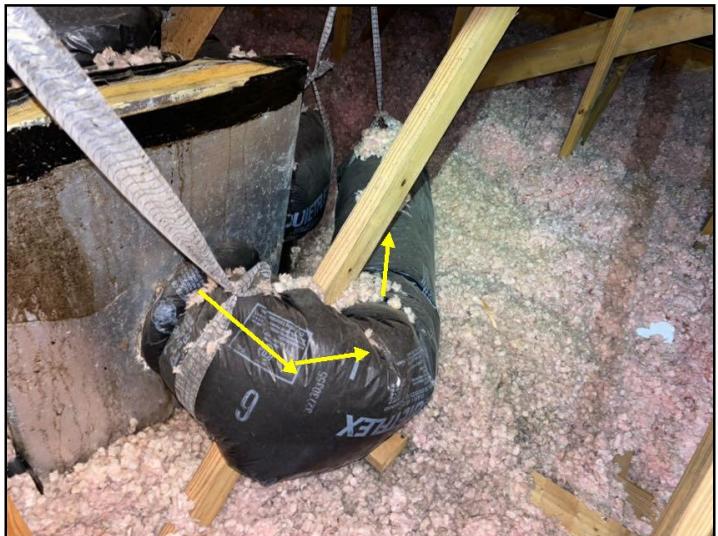
Portions of the ductwork have sags and need to be supported. Sags will reduce airflow

Some ducts have sharp bends. This will reduce airflow to these rooms/vents.

VIOLATION! No kinks in ducts

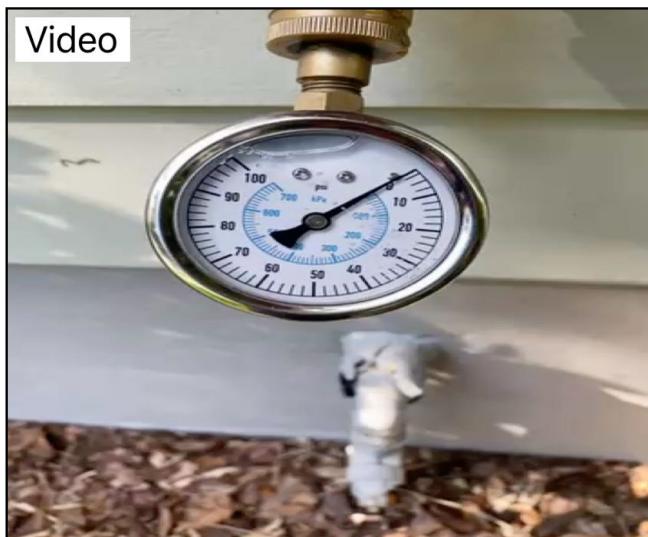
- Water pressure exceeded 80 pounds per square inch (psi) at the time of the inspection. This is considered excessively high. Acceptable water pressure is between 40 and 80 psi. Excessively high water pressure can cause leaks and pipe damage. The Inspector recommends contacting the utility company to lower the pressure or installation of a pressure regulator by a qualified plumbing contractor if the home is not equipped with one.

Video showing the water pressure is way too high. This needs to be lowered below 80psi.

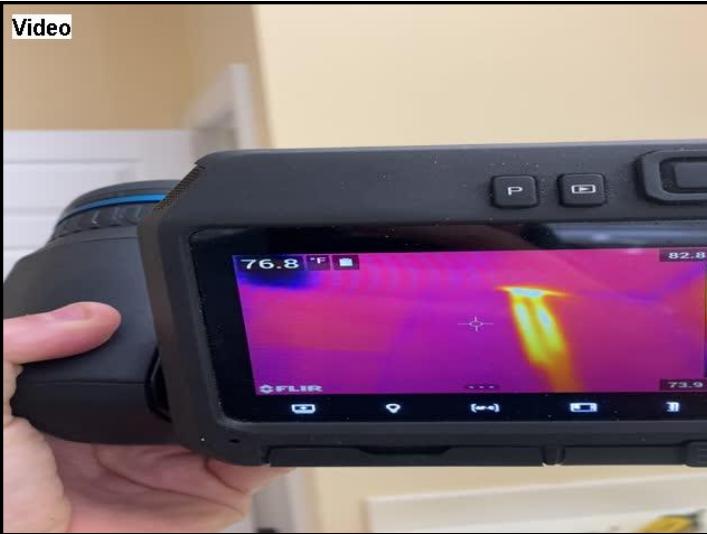
Leak detected coming down the wall in the master bathroom.

Video showing the area in the master bathroom where water is coming down inside the wall. This is below the shower upstairs.

- Stains on the ceiling visible at the time of the inspection appeared to be the result of leakage from plumbing fixtures or pipes located in or at the floor above. The moisture meter showed elevated levels of moisture present in the affected areas, indicating that the leakage had been recent. The source of leakage should be identified and corrected. The Inspector recommends that before the expiration of your Inspection Objection Deadline you consult with a qualified contractor to discuss options and costs for correction and repair.

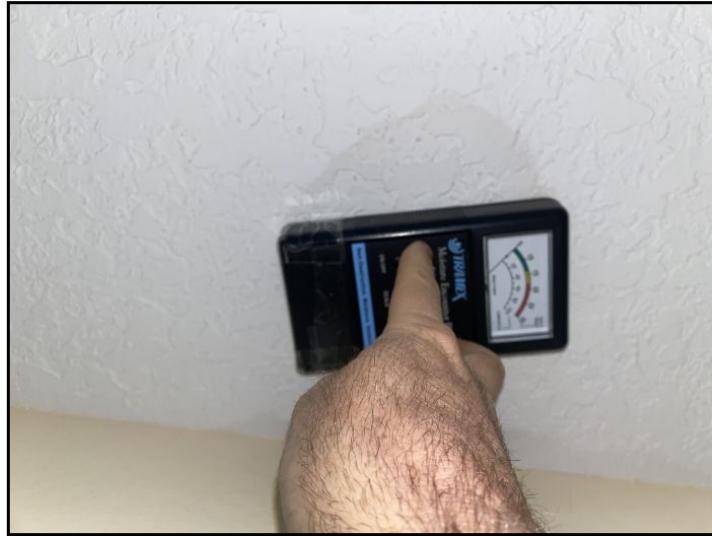
The two spots below the downstairs air handler are dry. This may have been from a past condensate line backup.

Meter showing the spots were dry.

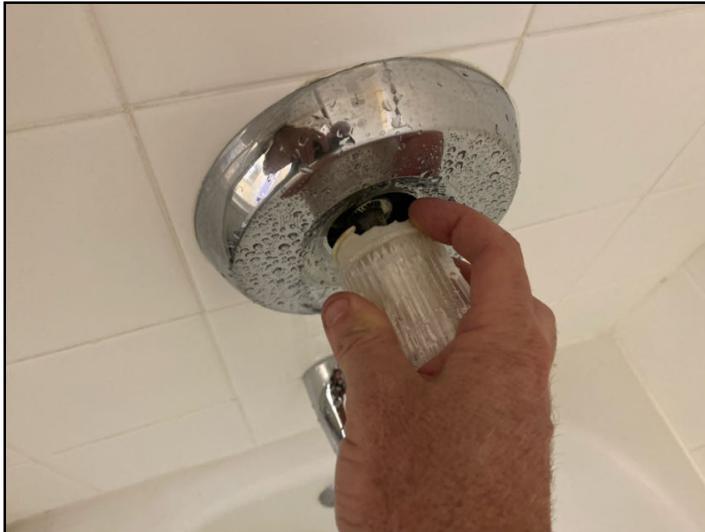
- This shower faucet had a loose or damaged handle at the time of the inspection. Recommend replacement.

The handle in bathroom 1 is damaged. This will allow water to get behind the tile. I would have it replaced.

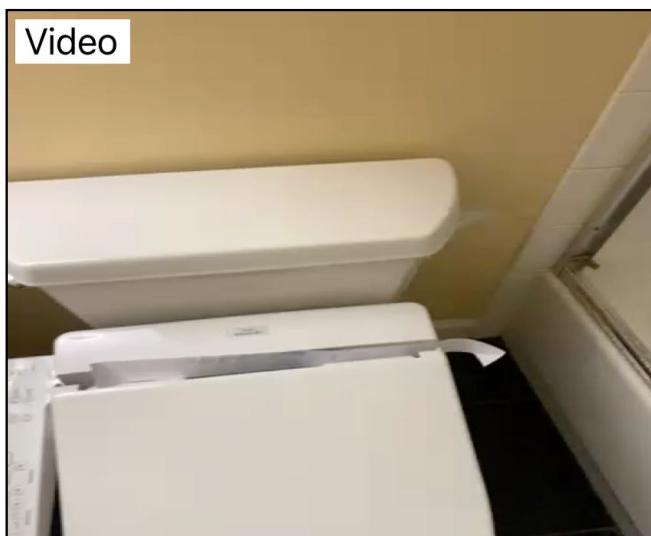
- The toilet was leaking at the tank. Recommend repair or replacement by a licensed plumber.

Video showing the toilet in bathroom 1 was spraying out of the top of the tank.

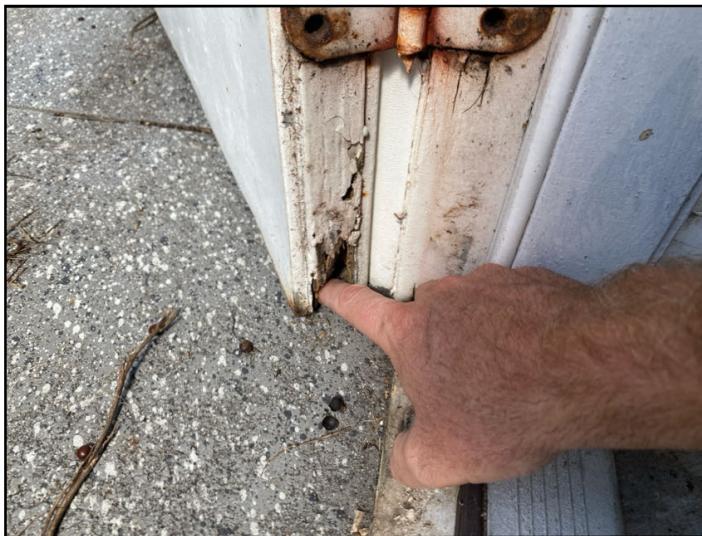
- An exterior door exhibited general moderate damage or deterioration at the time of the inspection. Before the expiration of your Inspection Objection Deadline you may wish to consult with a qualified contractor to discuss options and costs for repairs.
- The door in the master bedroom has had the strike plates replaced at some point. The way they are installed now is causing the door to not sit against the weather stripping. Recommend correction by a licensed contractor.

The door leading to the garage is decayed at the bottom. This is normal for doors that do not have much of an overhang at the exterior.
